First Presbyterian Church of Marietta

Preservation Plan and Assessment of the Historic Sanctuary Structure

Lord Aeck Sargent Architecture, Inc.

October 24, 2008

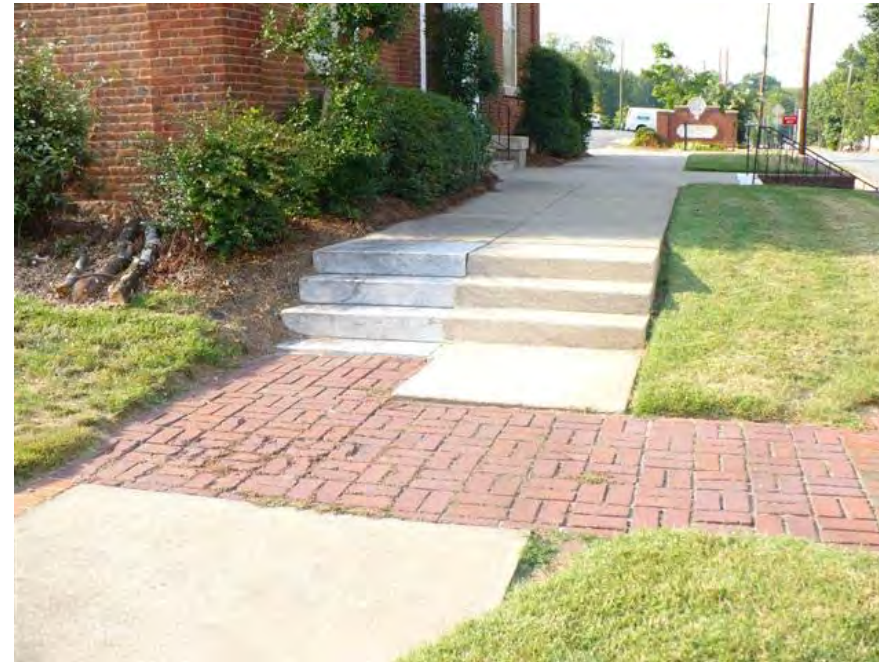
The double steps at the sidewalk could be reworked to create uniformity and replace the concrete ones with marble for aesthetic reasons only. The basket weave brick sidewalk paving could be restored by removing/replacing deteriorated brick.

Double material steps: marble and concrete

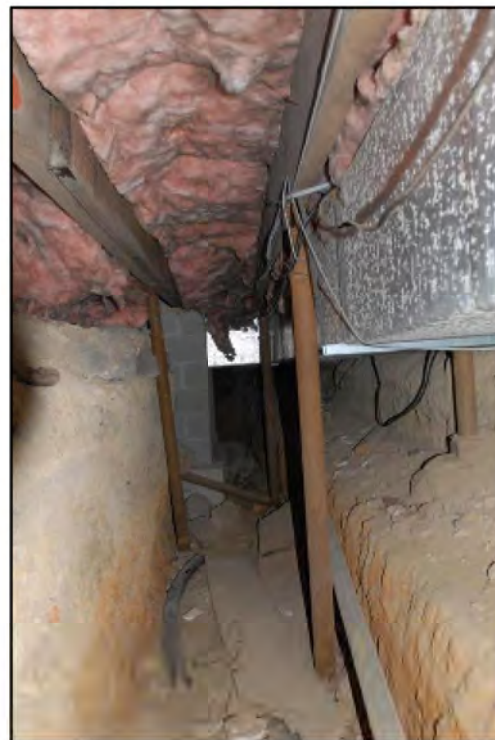
Granite exterior foundation wall to the left, ductwork on compressed soil to the right

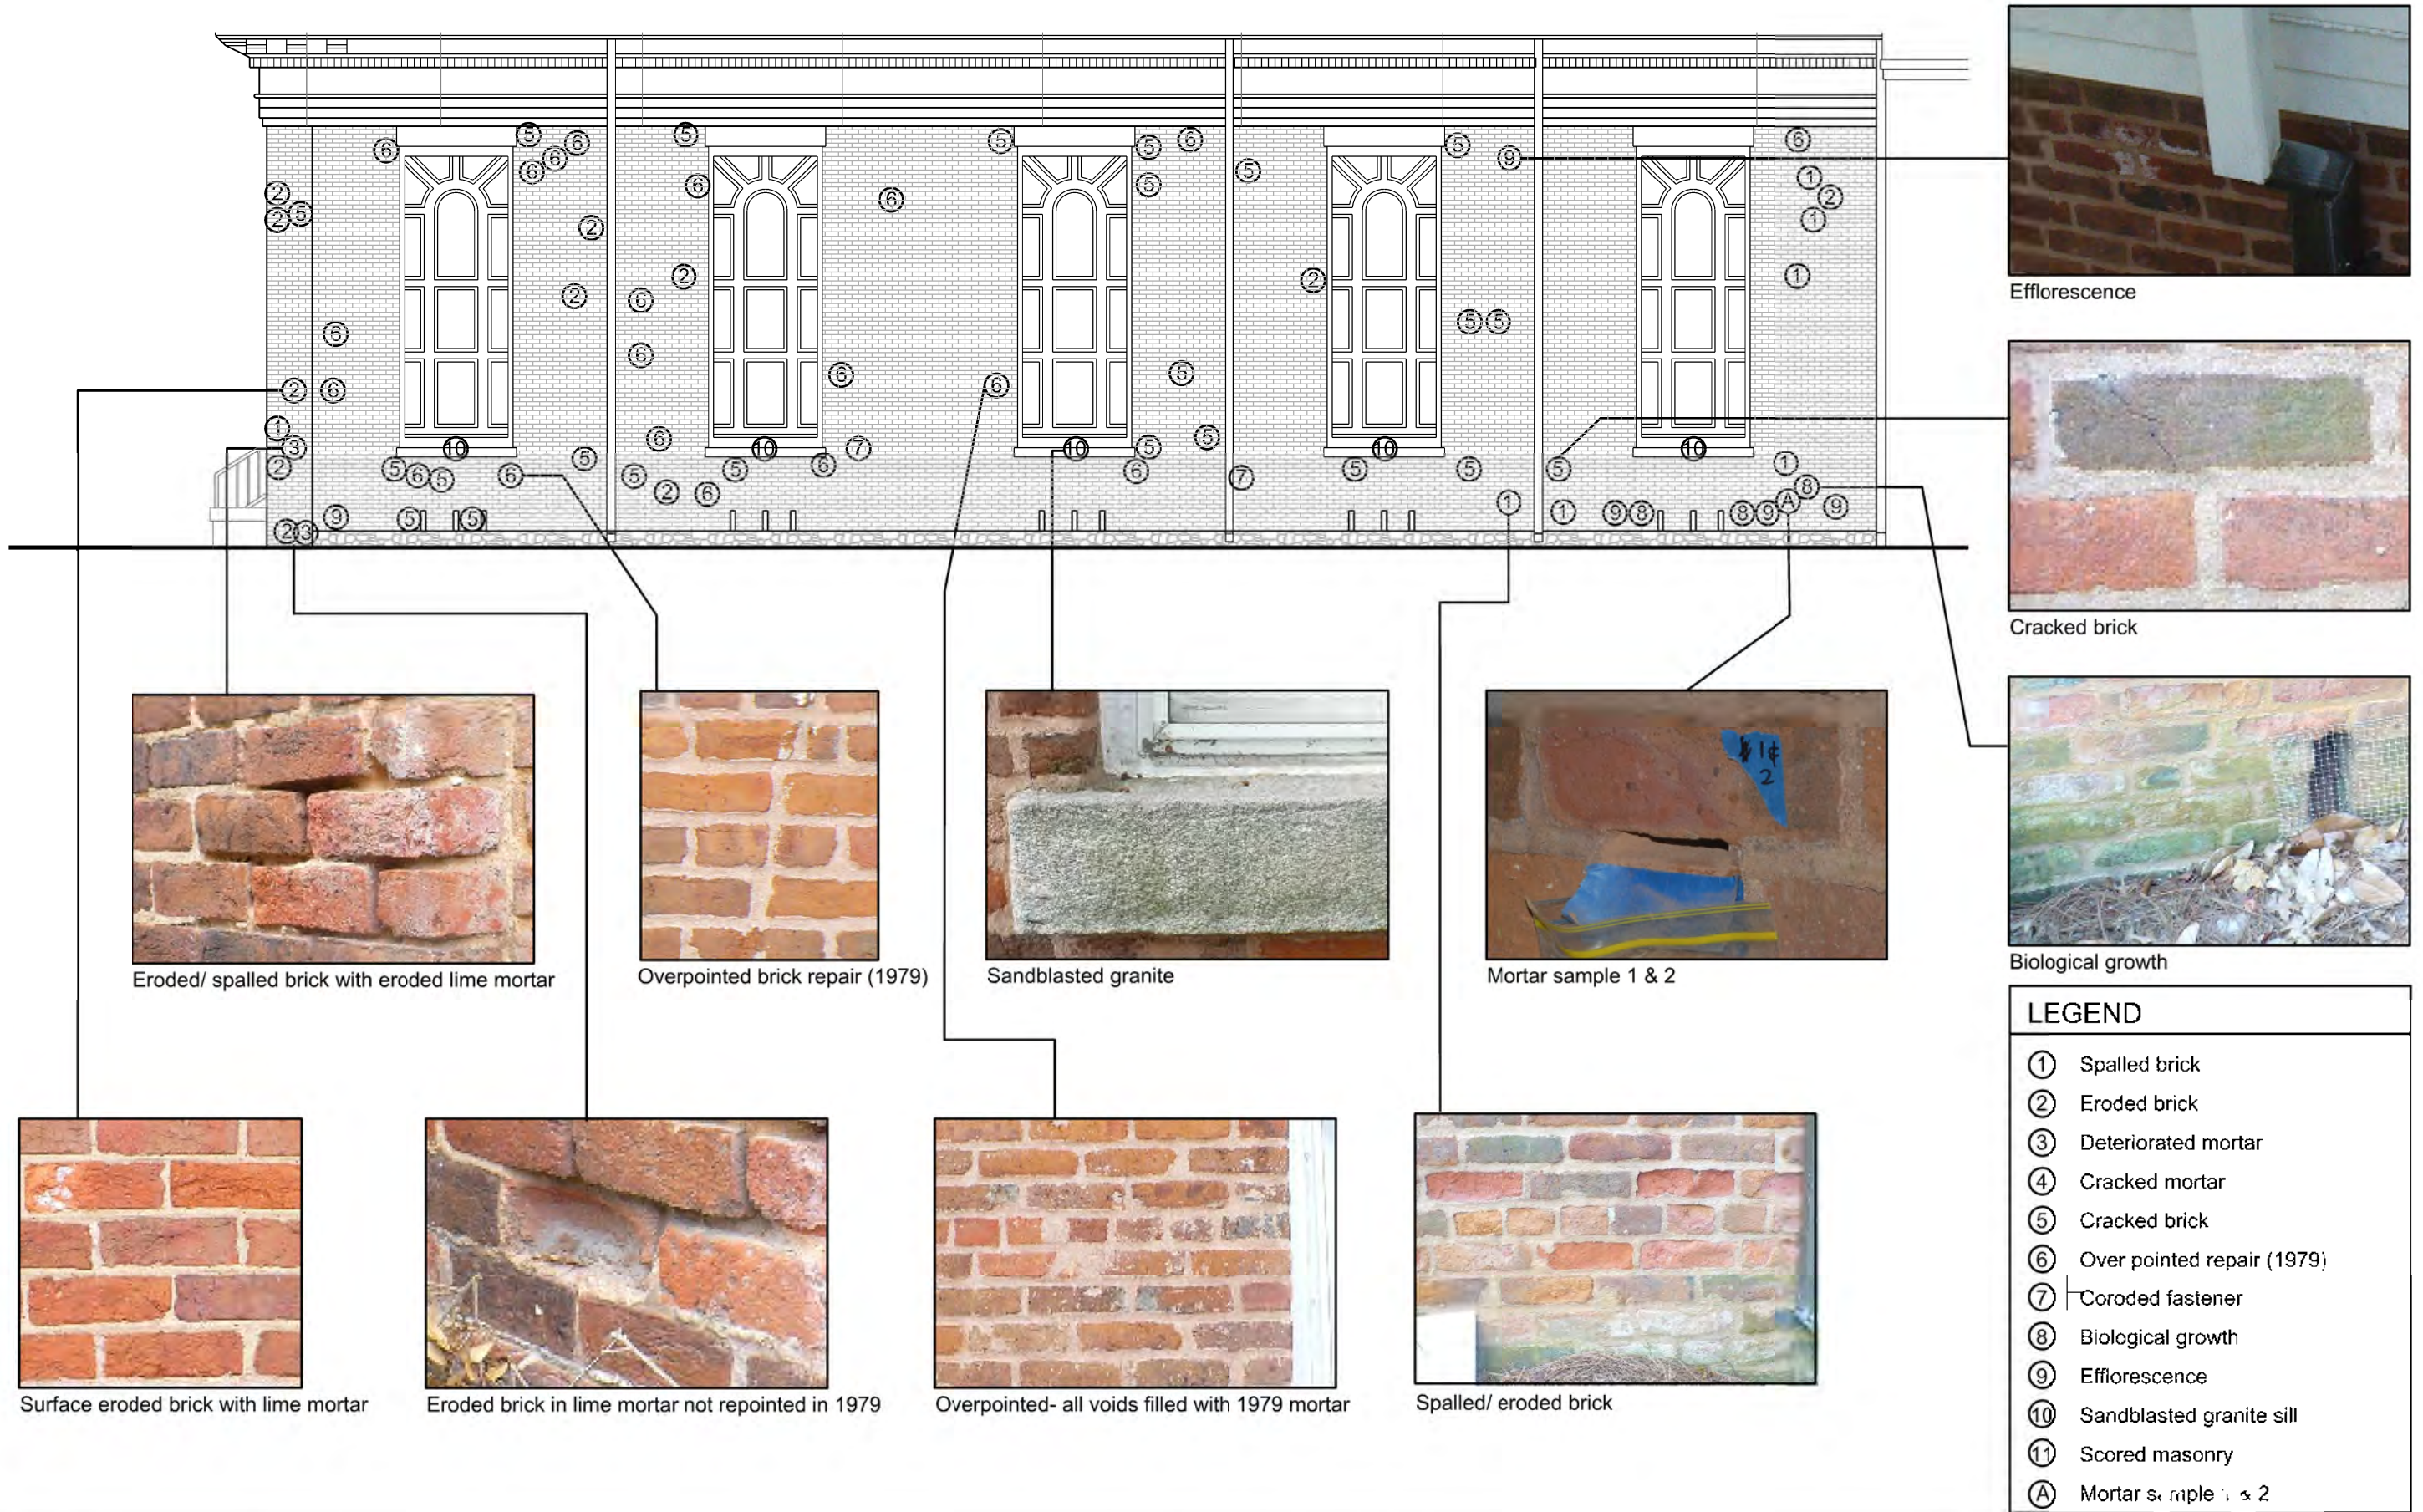
Efflorescence

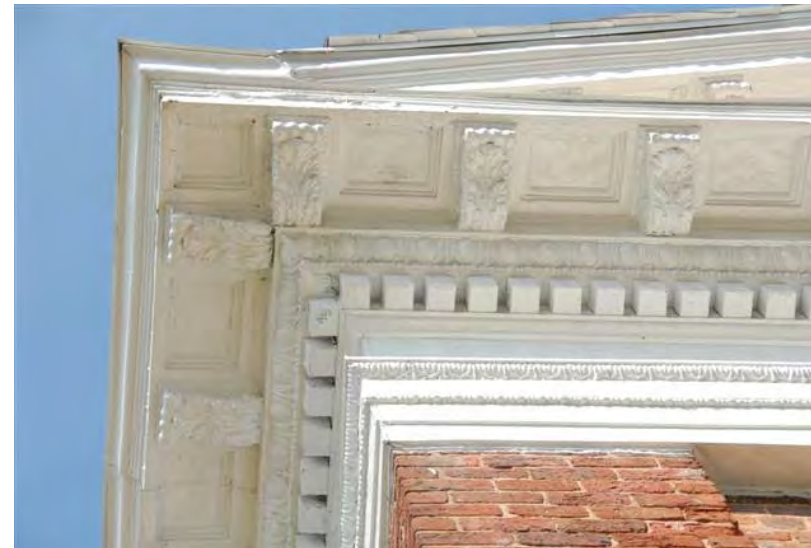
For the most part, the painted metal is in good condition. There are only minor scratches and cracks in the paint. In some areas, the metal cornice detail is damaged. The locations of minor damage and paint cracking are also documented in Division 7.4 Roof Assessment.

Thin sheet metal cornice and entablature at east gable

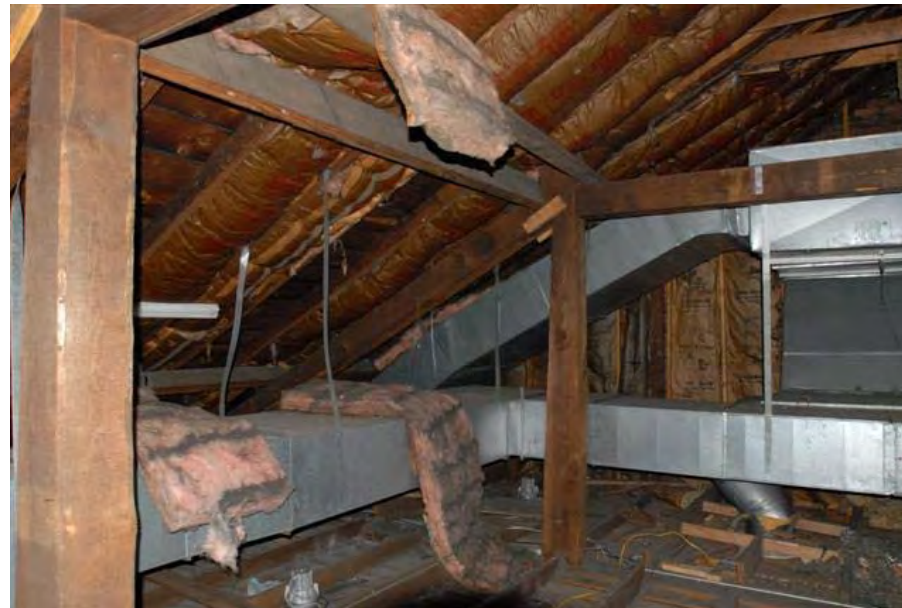
Original 1853 heavy timber framing in the attic; note insulation detaching from roof underside.

Recommendation: See East gable wall below

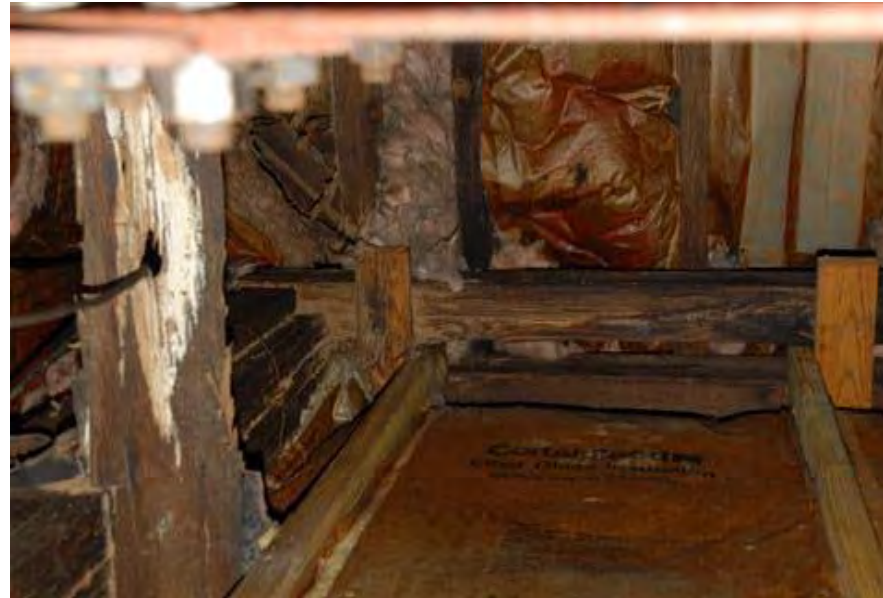
Double Beam across the gable wall and original post all shows signs of deterioration; (southwest corner).

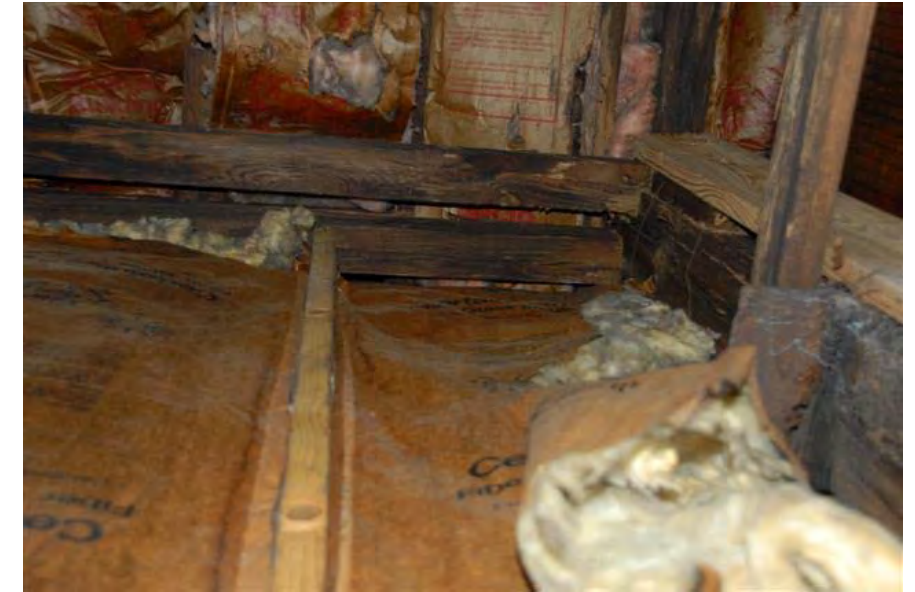
Double Beam across the gable wall, original post shows signs of deterioration; new board material attached to support the horizontal load (southeast corner).

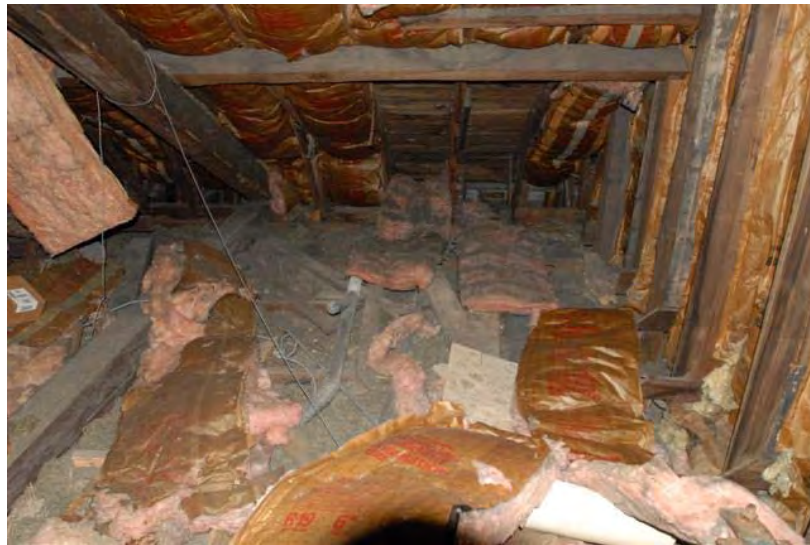
Failing insulation in the front section of the attic

Recommendation: Remove all batt insulation from the attic space. Check for water leaks and possibly required repair to the rafter and sheathing before re-insulating with a more efficient and durable insulation system. Spray-on insulation may be suitable - will achieve a higher level of insulation and remain in place more reliably. It will also be more environmentally friendly than the currently applied batt insulation.

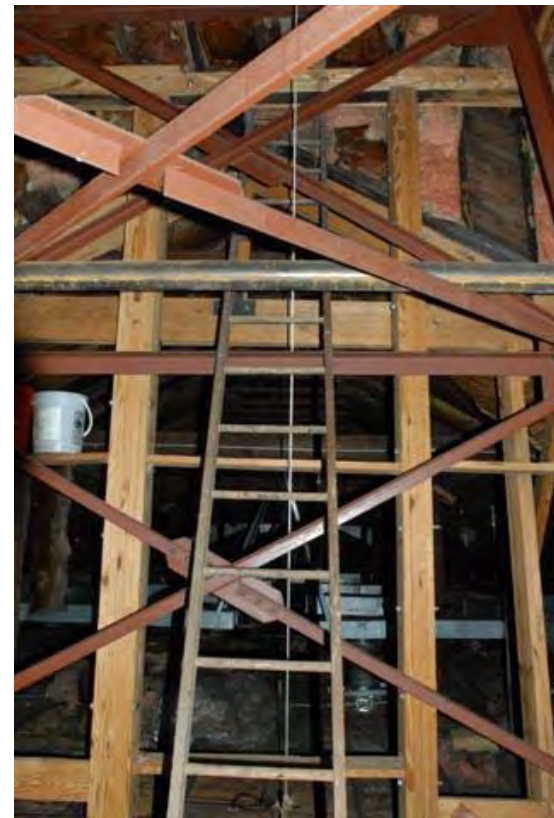
Observation from inside the tower base has revealed that the floor framing above the tower base structure - which is the floor on which the bell carrier is resting - is mostly sound in its central portion but rather deteriorated along the perimeter and particularly at all four corners. There are several detailed images to make this point. On the south-west side of the tower, the rafters are partially deteriorated (and/or removed) and have been covered with plywood in a clearly temporary way. The northwest corner shows similar levels of water damage on the rafters/joists and from below/inside there was no new installation of plywood visible. These two west side corners of the tower base top are structurally well supported since a post 1979 structural wood support system had been installed.

Additional structural support for belfry floor rafters

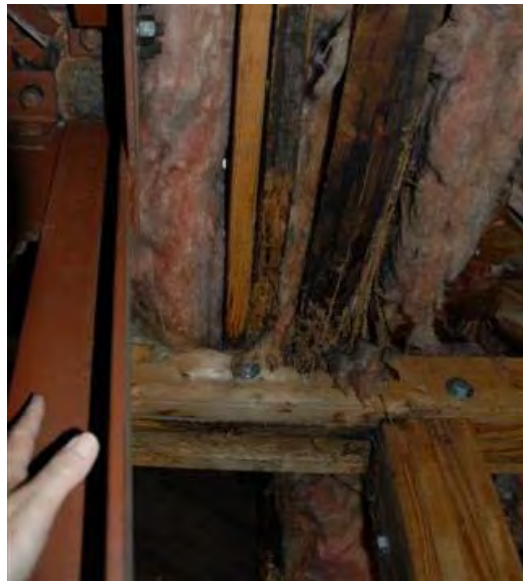
Floor joists for belfry floor, outside of the steel frame, SW corner

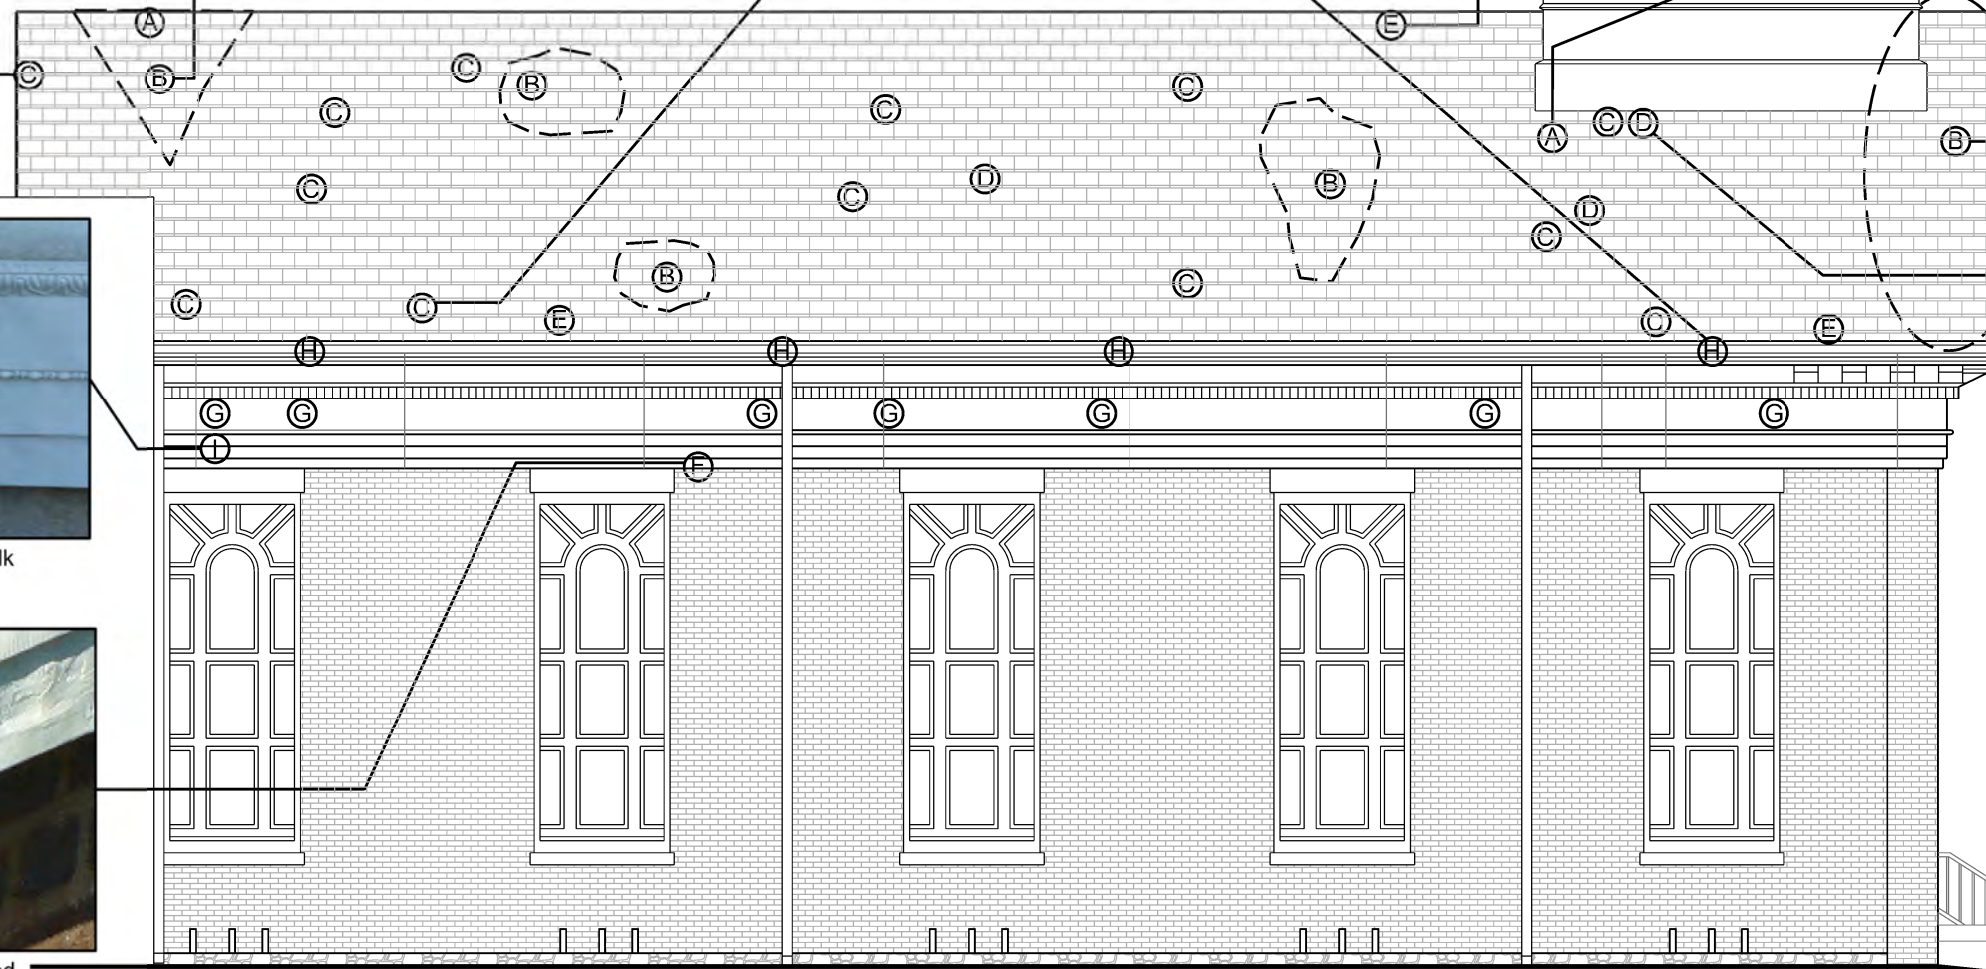
Metal entablature repaired with caulk

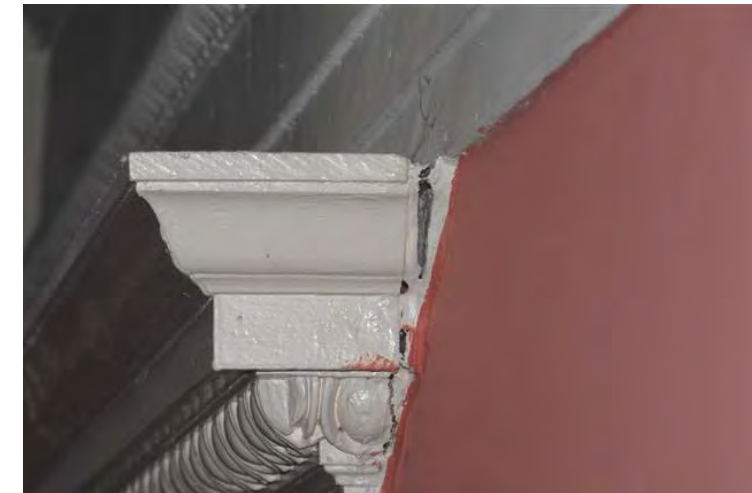
Window 4: Header trim detaching

Recommendation: Besides a few paint corrections and possibly a glass replacement to match the original there are no major issues with the windows, besides routine maintenance. Window header at # 4 needs to be reattached to wall.

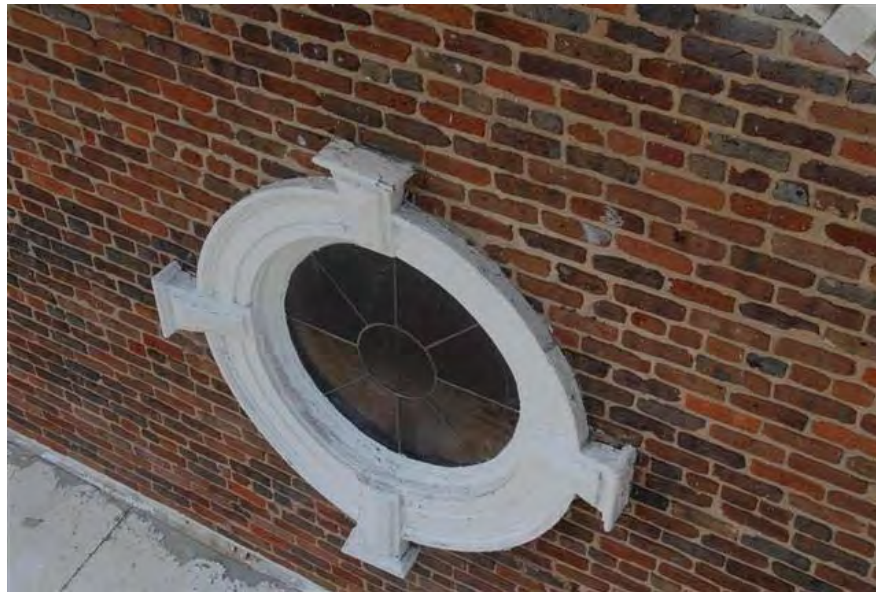
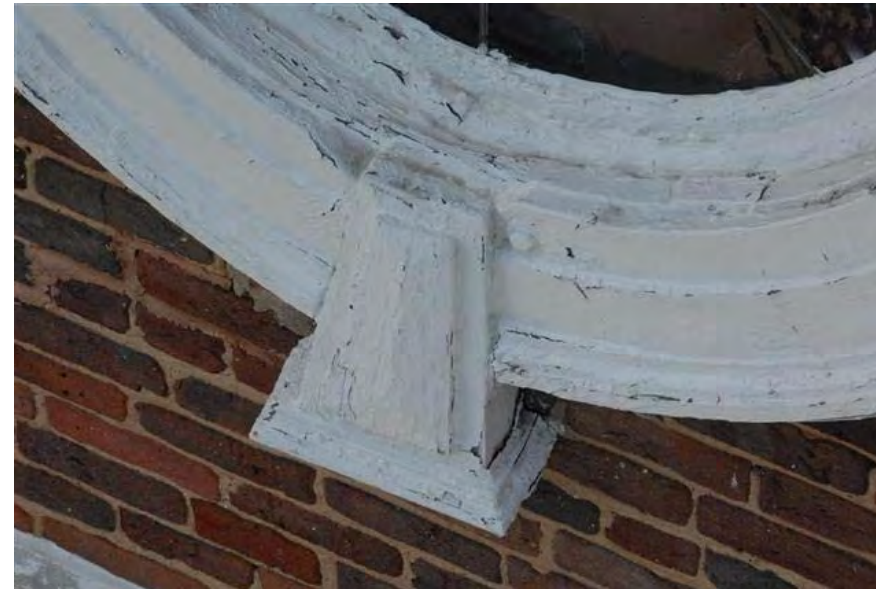
The exterior wood trim is still in a fair condition but does require paint removal, careful priming and painting after possibly applying wood restorer to strengthen deteriorated segments.

Recommendation: Fully restore round wood window, reinforce with wood restorer, prime and paint. Assess requirement to introduce a circular stainless steel lintel for structural reinforcement and to stabilize the gable wall.

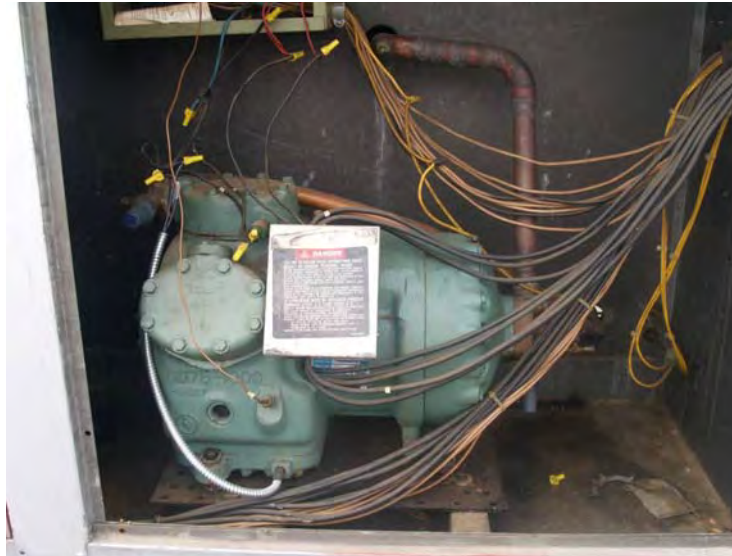
9 Rooftop Unit Compressor-Good Condition

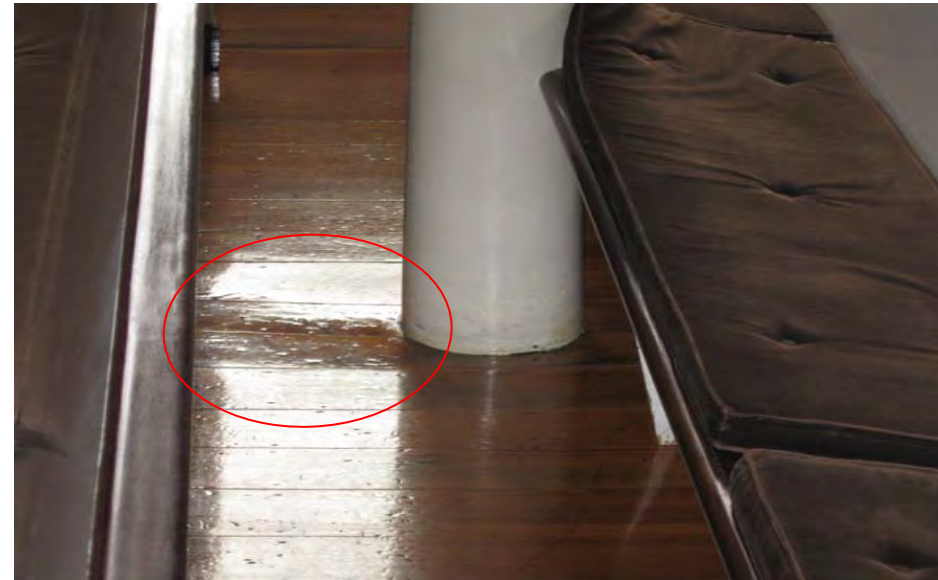
Photo 1 – Slab depression at Post Base

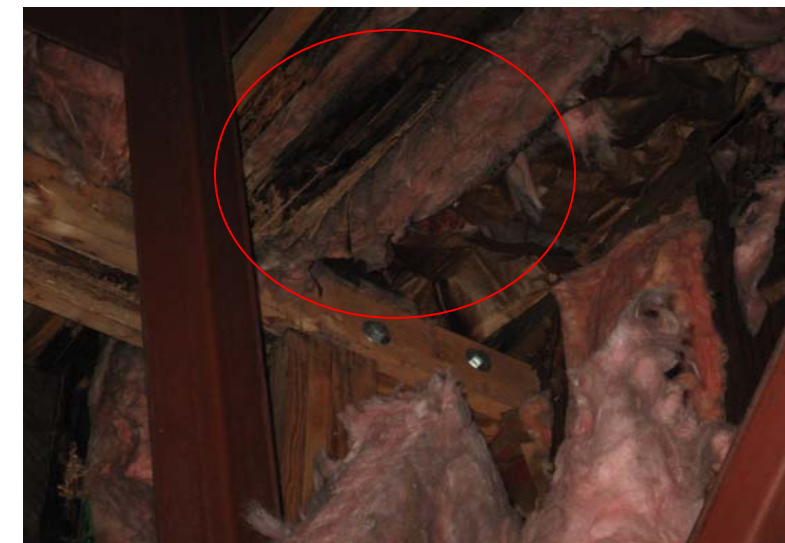
Photo 16 – Damaged Wood below Steeple
