First Presbyterian Church of Marietta

Preservation Plan and Assessment of the Historic Sanctuary Structure

Lord Aeck Sargent Architecture, Inc.

October 24, 2008

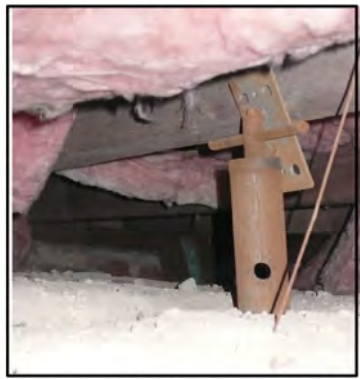
Steel post failing to support joist

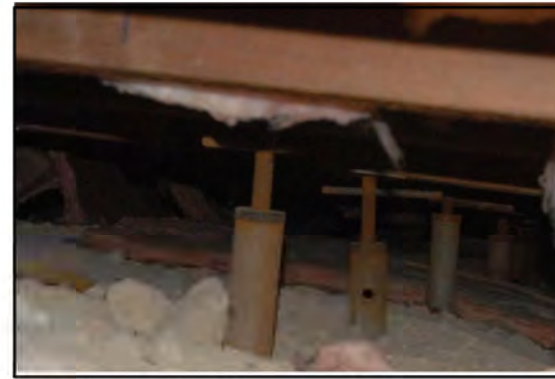
Typical steel jacks to support floor joists at midspan.

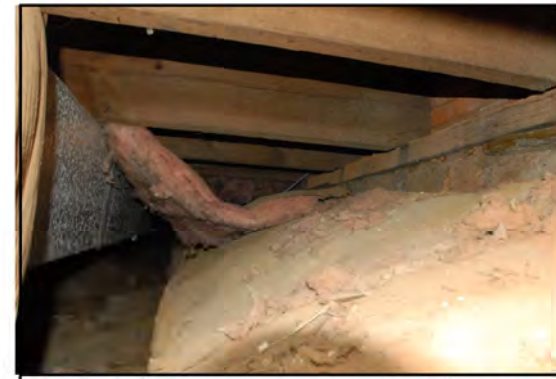
Compacted soil between mechanical duct trench and exterior foundation wall

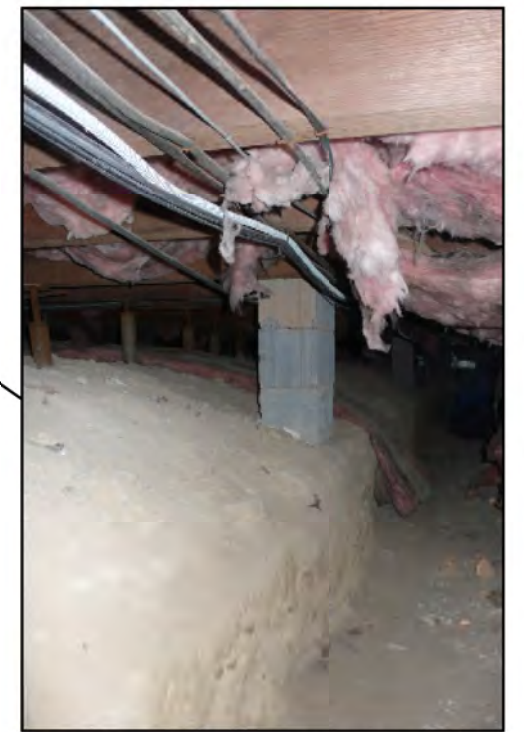
Concrete block supports too close to edge of compacted soil

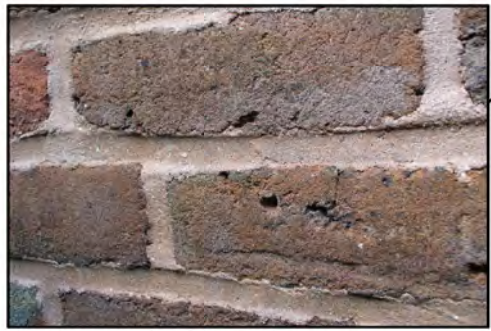
Failing brick surfaces

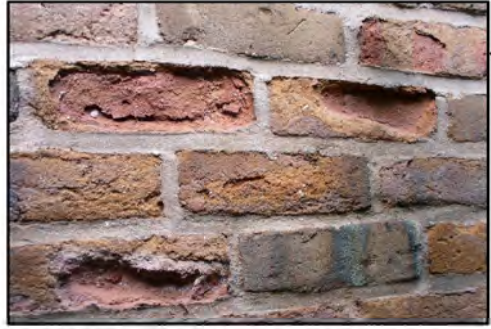
The 1979 scope of work did ask for replacement of broken and damaged brick (spall damage?) but that was not documented and it is not currently known if and how much of the original brick may have been replaced. There are three possible causes for the currently existing damage: A) the original brick was not quite as well produced and fired as desirable and therefore is not holding up any longer, i.e. it does show signs of stress and starts to exfoliate and undergoes spallation. B) Since the re-pointing mortar used in 1979 is not compatible with the 1853 brick it may causes the surface of some of the brick to spall. C) The specifications for the 1979 work did not ask for sandblasting the brick surfaces, but there is the possibility that the brick surfaces were treated abrasively at that time and is starting to show signs of weakness. All three causes could also occur together and reinforce each other.

Spalled/ eroded brick with 1979 mortar

In order to determine the cause and effect more clearly it would be necessary to carefully and selectively remove several bricks from the wall and test them for their compressive strength and water absorption characteristics. Before or during the brick testing is in progress it would be necessary to start with the replication process of the existing brick through custom brick producers since the exterior wall restoration will require some brick replacement under most circumstances. Since the brick removal and testing process may result in further loss of the bricks, the method of coring the brick and measuring the core may be an alternative testing solution.

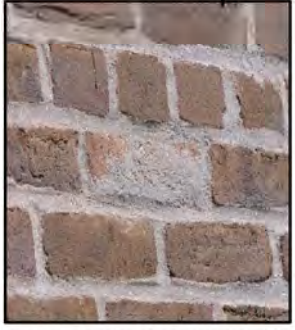
Over pointed repair in 1979

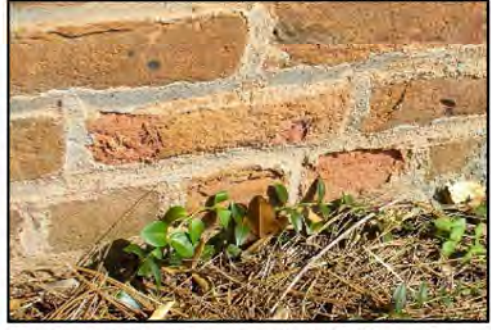
Spalled brick with repointed 1979 mortar

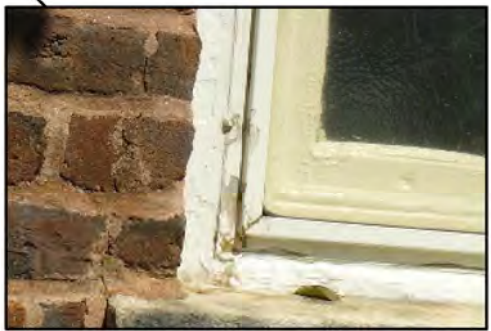
Stress crack in masonry next to granite sill

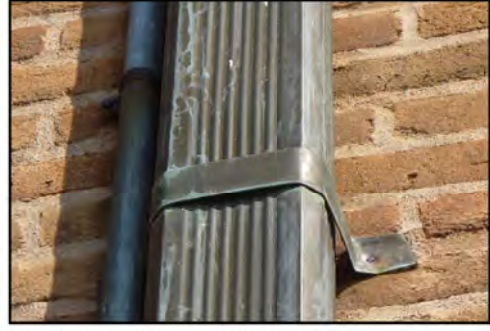
Rusting nail fastened into brick

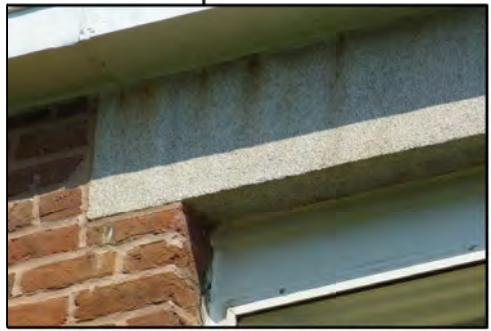
Granite lintel- sandblasted and stained

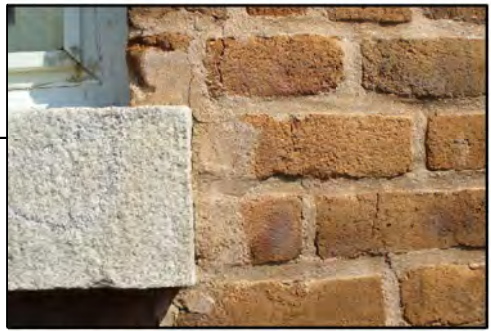
Over use of repointed 1979 mortar next to sandblasted granite sill

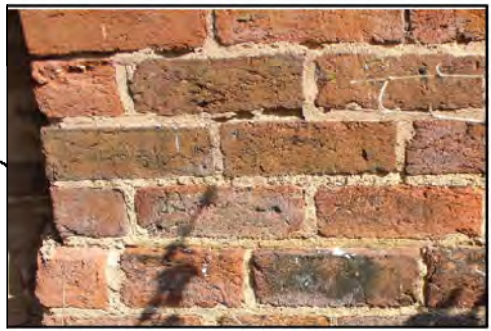
Eroded brick with deteriorated mortar

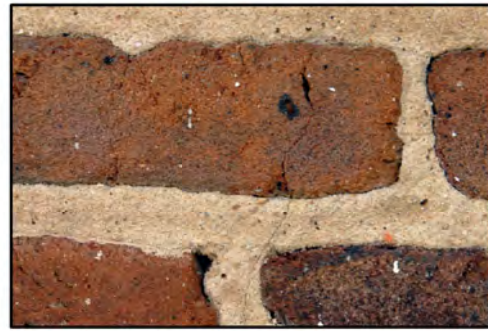
Strongly weakened masonry-
cracked brick and mortar

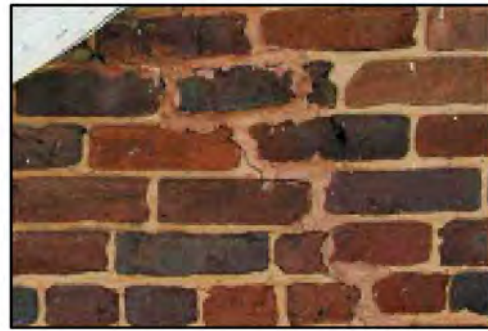
Poorly repaired masonry crack (1979)

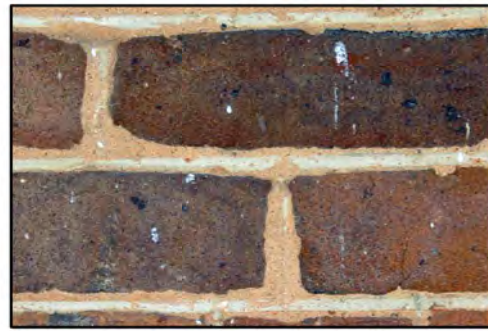
Remnants of paint or mortar coating

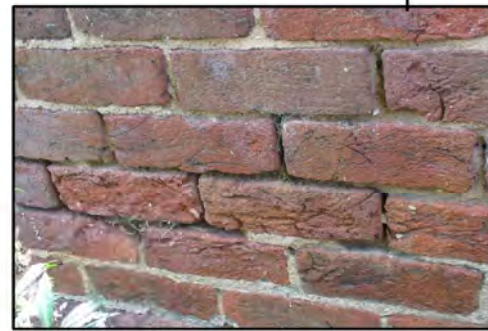
Eroded brick, failing lime mortar not
repointed in 1979

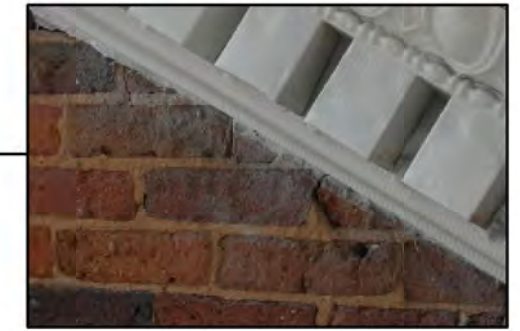
Oversprayed white paint on brick

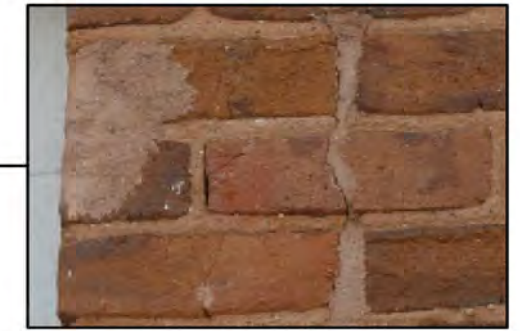
Over pointed mortar (1979)

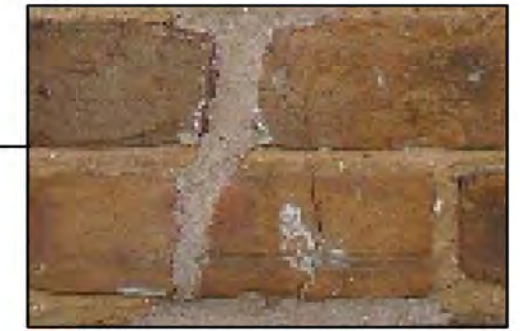
Cracked brick and non-matching mortar (1979)

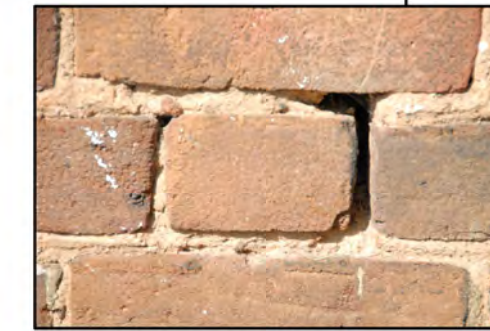
Failing lime mortar

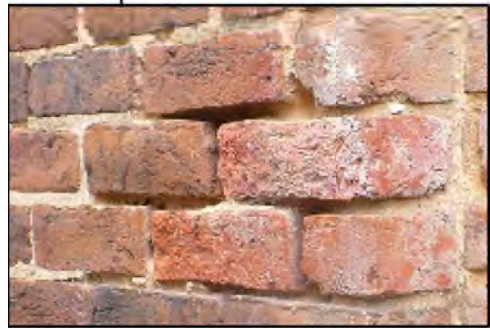
Eroded/ spalled brick with eroded lime mortar

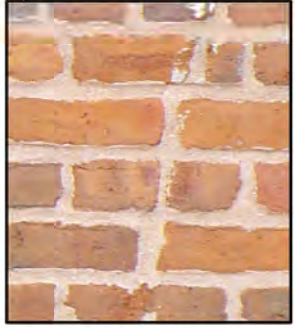
Overpointed brick repair (1979)

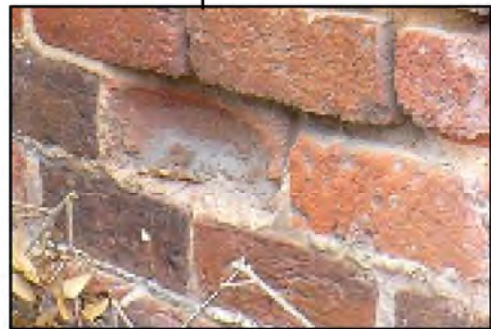
Eroded brick in lime mortar not repointed in 1979

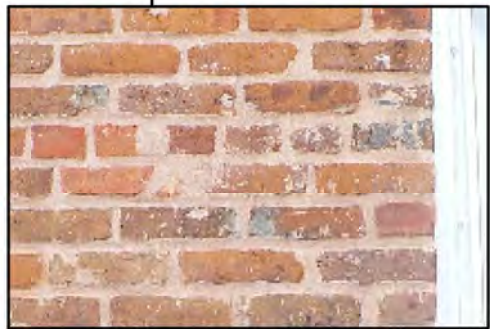
Overpointed- all voids filled with 1979 mortar

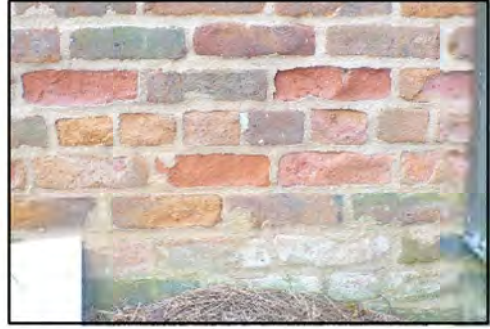
Spalled/ eroded brick

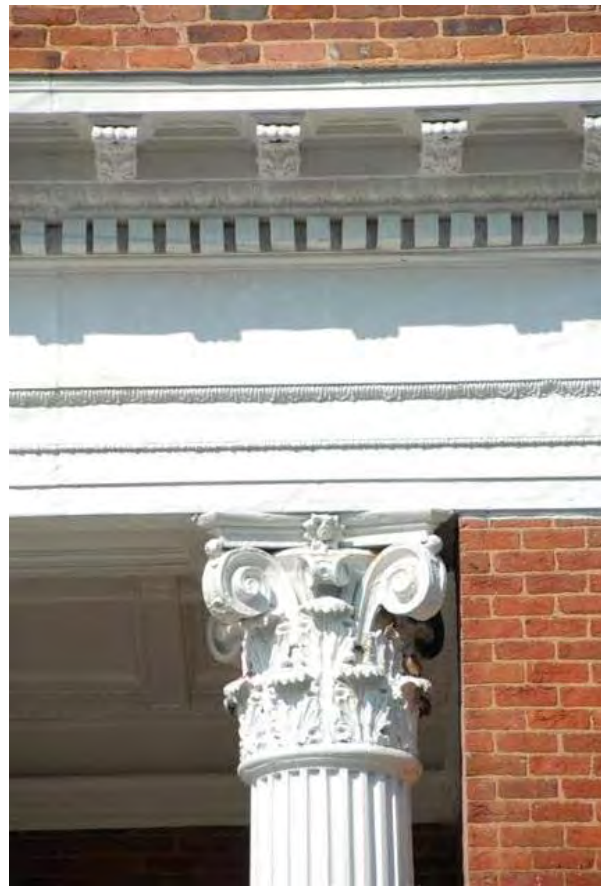
The Corinthian Capital is completely made out of thin sheet metal

Column capitals: The Corinthian capitals on either side of the narthex are completely made out of thin galvanized sheet metal attached to a semi-structural steel shaft. It is in fair condition and needs cleaning and repainting to protect it from corrosion. The various bent and horizontal surfaces do provide ideal nesting and resting perches for various birds.

Recommendation: Eliminate any water penetrations behind metal work. Remove all corrosion from all metal surfaces by chemical or, if required, abrasive means. In case of advanced corrosion, replace metal element, minimizing loss of historic material. Re-prime and repaint to match existing. In case of the capitals, treat inner shaft with rust inhibitor and prime/paint to protect. Clean all surfaces intensively and review bird protection options if desired.

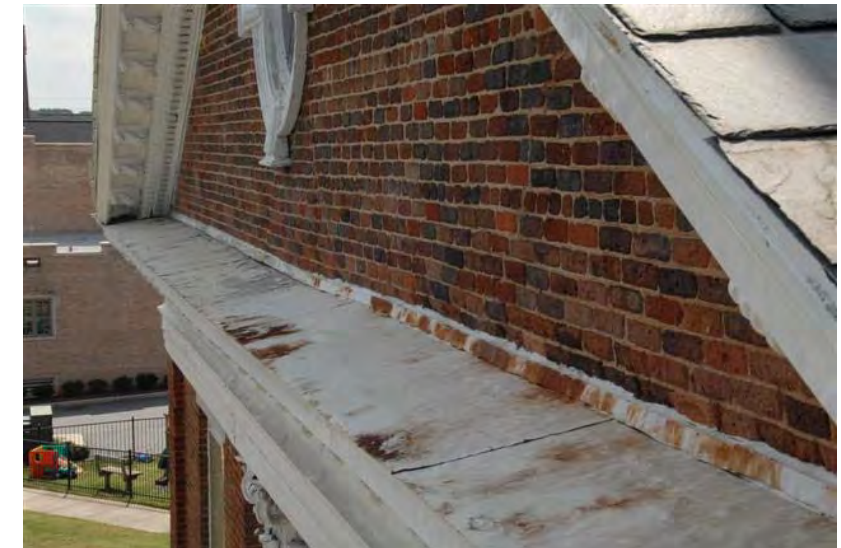
Cover metal sheet across the horizontal cornice at east gable

The horizontal cornice at the east gable is in need of further investigation and most urgently corrosion protection. The flashing at the wall may also be in need of upgrading. The substructure inside the cornice is unknown and may need to be inspected for structural integrity.

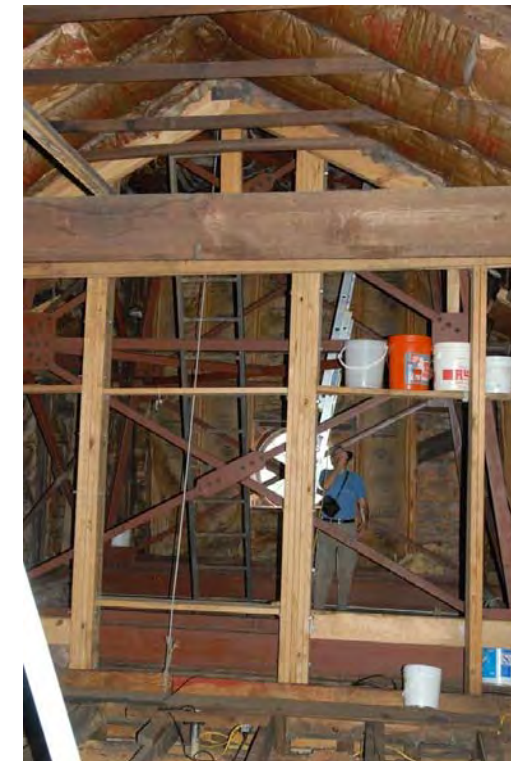
Buckets are lined up for drip water collection (time frame unknown)

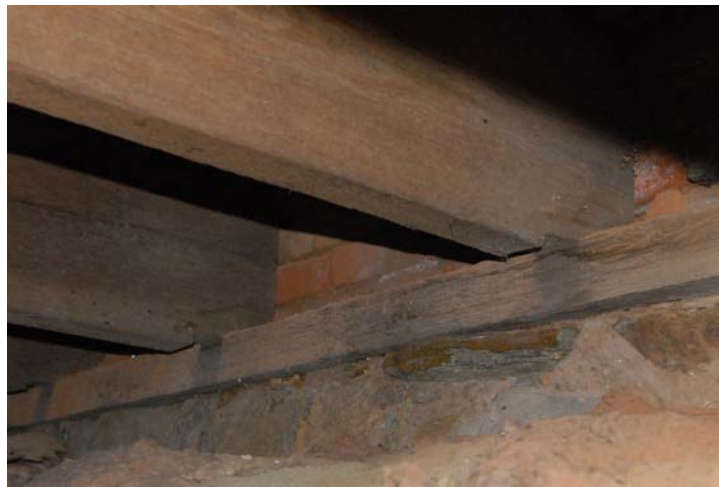
Sanctuary floor framing: The sanctuary floors are in good shape and feel very solid. The central support for the floor joists is provided by a granite masonry wall with a center plate on top to hold the floor joists is also in good condition. Since the granite wall runs underneath the central aisle of the sanctuary, there is a slightly elevated ridge noticeable along the floor in the center of the aisle. The relative firmness of the floor has also been generated by the installation of adjustable steel jacks at regular intervals and at approximately at the mid point of the span. Temporary block foundations support the floor at each balcony column location. See Structural Report in Appendix A.

Floor joists on top of the granite foundation wall, at the base of the exterior brick wall.

Recommendations: Inspect all adjustable jacks and adjust their carrying tension sufficiently to support the joists without exerting too much upward pressure on to the floor. Replace/apply new insulation.

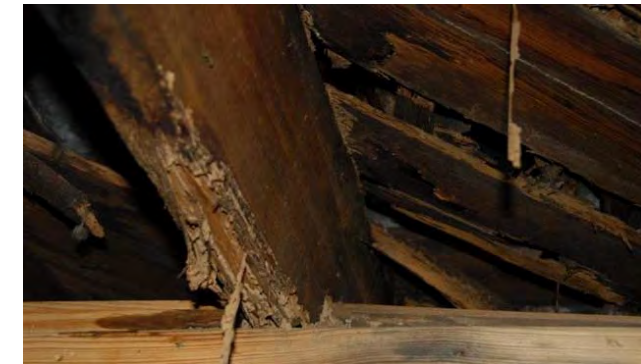
All rafters are supported from below by a beam running north-south - the rafters running from east to west. However it is the condition at their ends, at the corner, which are no longer holding up. There is a high probability that the framing of this belfry floor is still the original framing, either from the first tower of the church (1853) or from the 1905 version of the tower. In either case it may be necessary to consider reworking this floor/roof surface to make sure that it is fully sealed again and long lasting, with a new and improved roof surface - lead coated copper or similar. See also section drawing A301.

Water damage to beam at belfry floor, NW Corner

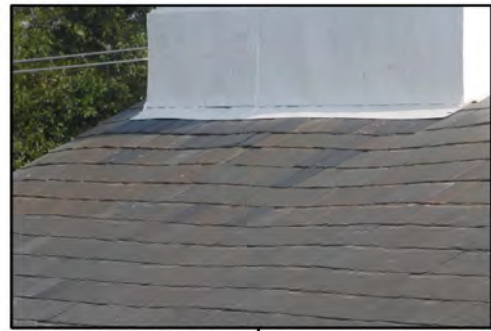
Sagging eave roof plane

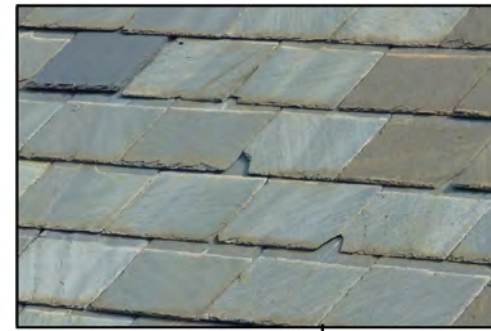
Chipped corners of original slate

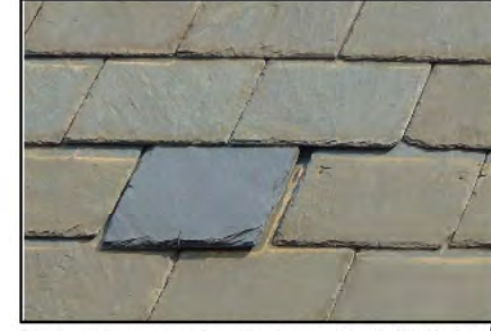
Black replacement slate tile does not match existing

Recommendations: Replace all tiles which have slipped and fell off the roof. Possibly replace the black repair tiles, particularly in areas where they are the only tile in a surrounding of original grey slate tiles.

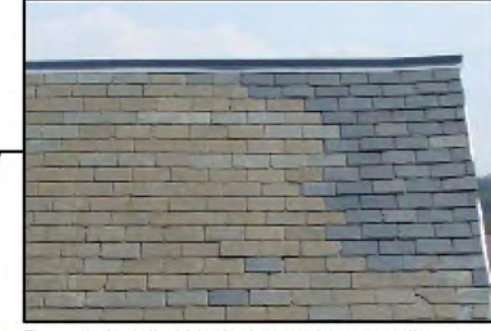
Recently installed black slate replacement tiles at West end of roof

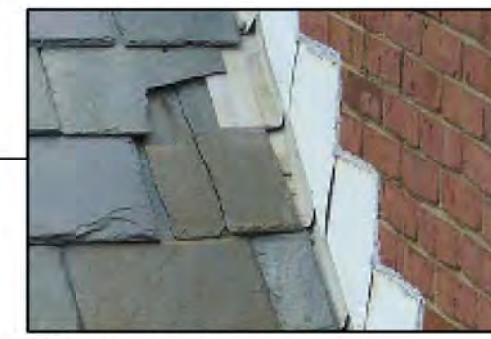
Falling/ missing slate repair

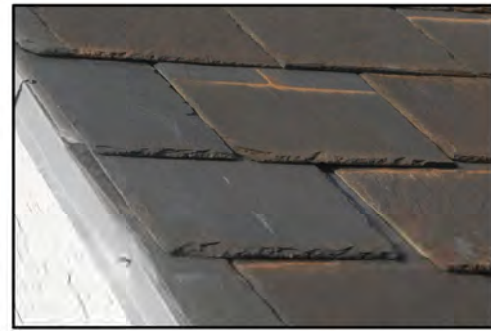
Black replacement slate does not match size of previous tile

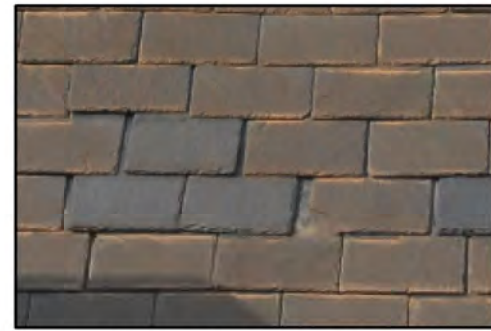
Black replacement slate is not wide enough

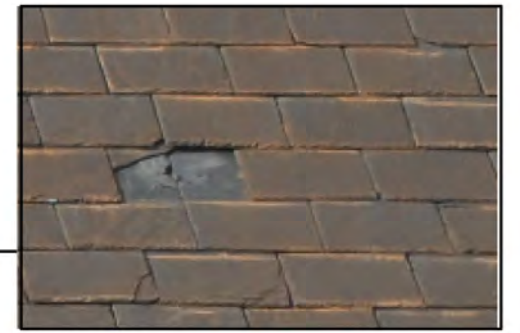
Missing slate tile

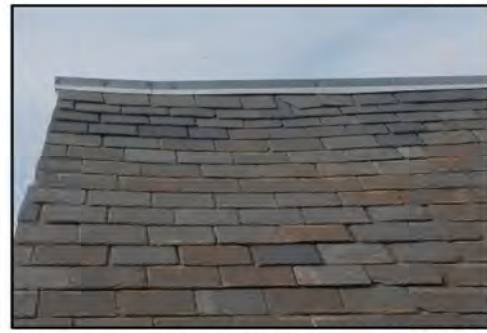
Sagging ridge line with black replacement slate tiles

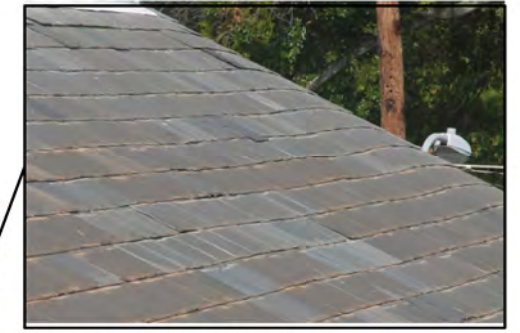
Sagging eave (curved surface)

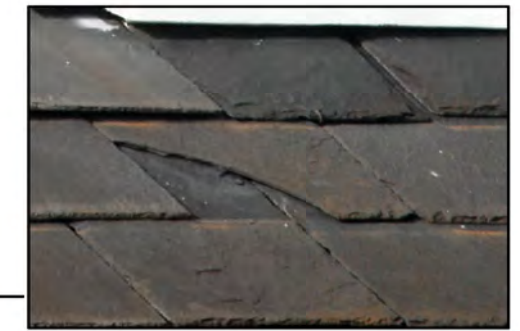
Major chip in slate tile

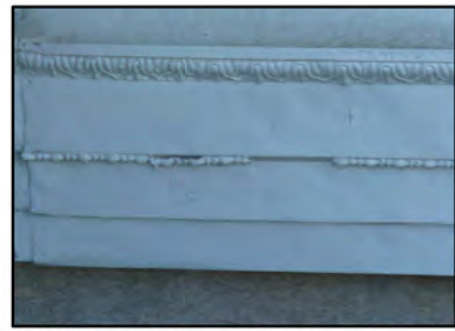
Metal entablature repaired with caulk

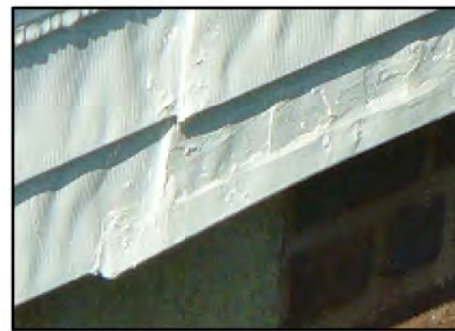
Metal entablature repaired with wood

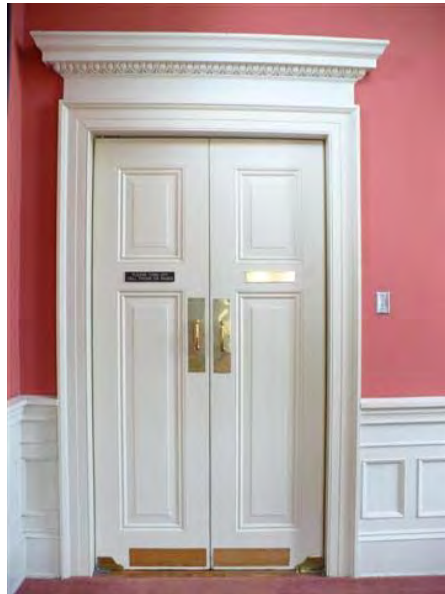
Doors #103 and #104 connect the two stair vestibules to the sanctuary. The double doors swing outward into the vestibule toward the exit, with modern brass push plates, pull handles, kick plates, and signage. The center pivot hardware is mounted at the header and wood threshold. Each door features two raised panels.

Door 103 seen from Stair Vestibule

Recommendation: Review for ADA compliance and easy function of all hardware elements. Consider panic hardware for general security in addition to code requirements. Review all door width and direction of door swings for code and security purposes.

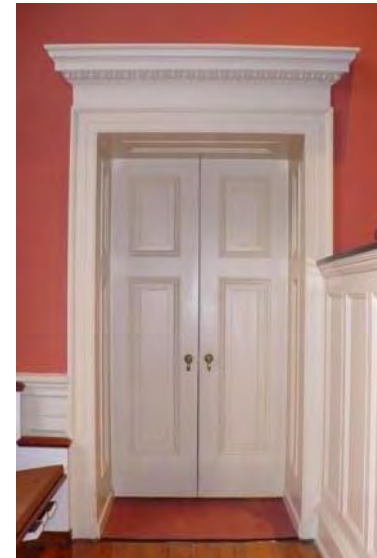
Doors #105 and #106 connect the sanctuary to Holland Hall. The double doors swing toward the exterior of the sanctuary with modern brass knobs and latch bolts styled to match the historic brass hardware found on the east exterior doors. The doors match the raised double panel format of doors 103 and 104. The sanctuary side of the door is recessed 2'-0" beyond the plaster walls, with a carpeted threshold and wood paneled door frame at the header and jambs. The Holland Hall side of the door is flush to the wall with inscribed corner medallions replacing the typical egg and dart header trim. Doors 105 and 106 function as the ADA accessible entrance to the sanctuary. To comply with ADA requirements, one of these entrances should have an automatic door opener. The reason for this requirement is that the individual width of the door leaf is insufficient to accommodate a wheelchair and the wheelchair user cannot be expected to open a double door.

Door 105 seen from Sanctuary

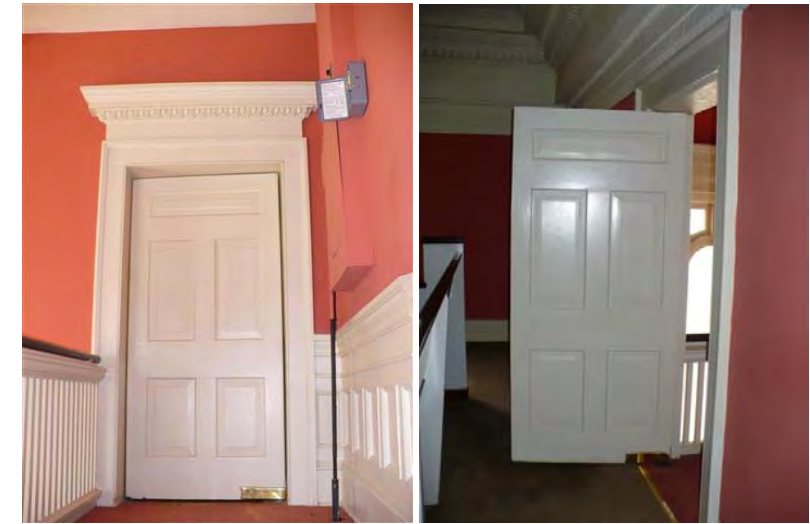
Doors # 201 and # 202 connect the stair vestibule with the balcony. These 5-panel doors have swivel hardware, allowing them to swing into the balcony space and into the stairwell landing. However there is no responding hardware mounted on the stair side. The center hung pivot hardware is mounted at the header and threshold. Door 202 exhibits some damage to the door where it is connected to the pivot hardware at the header and threshold. Door 202 has a wood threshold and evidence of a previous knob and keyhole. Door 201 was only installed during the construction of the North stairwell in the early 1970s.

Door 202 seen from South Stair

Door 201 seen from balcony

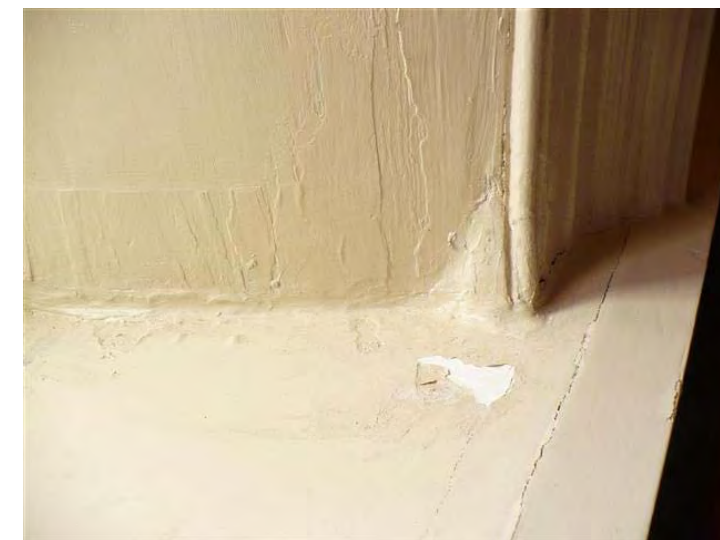
The interior window trim is 5-1/2" wide and matches the flat frieze with egg and dart entablature of the door headers. The interior trim is in good condition except for certain locations. At window 4, the header trim is beginning to detach from the wall. During the 1979 renovation, windows were repainted on the interior and exterior. However, paint was not fully removed at all locations such as the interior of windows 2 and 12, and the

exteriors of windows 9 and 10. The painted interior mullions of windows 2 and 12 are peeling significantly. At windows 3, 7, 8, paint at the interior header is peeling. At window 10 the side trim paint has peeled down to a large patch of bare wood.

Window sill with old paint layers and new peeling

Recommendation: Besides a few paint corrections and possibly a glass replacement to match the original there are no major issues with the windows, besides routine maintenance. Window header at # 4 needs to be reattached to wall.

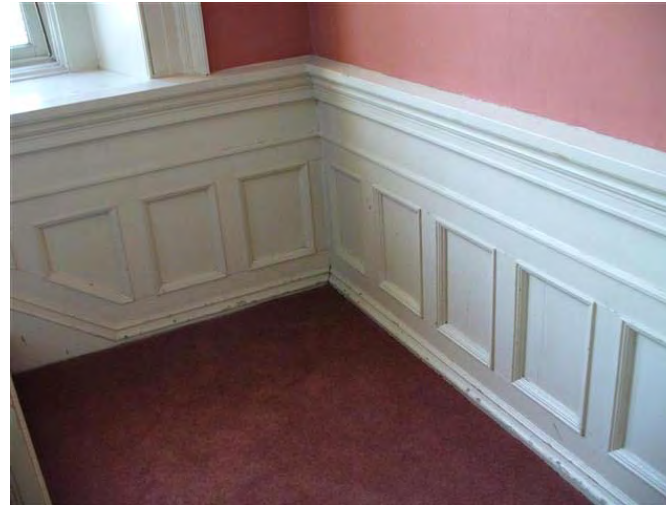
Both the stairwell floors are covered with a burgundy-red carpet. It is fairly new with a thick acoustical padding to absorb the sounds of stair traffic.

Carpet and wainscot in stairwell

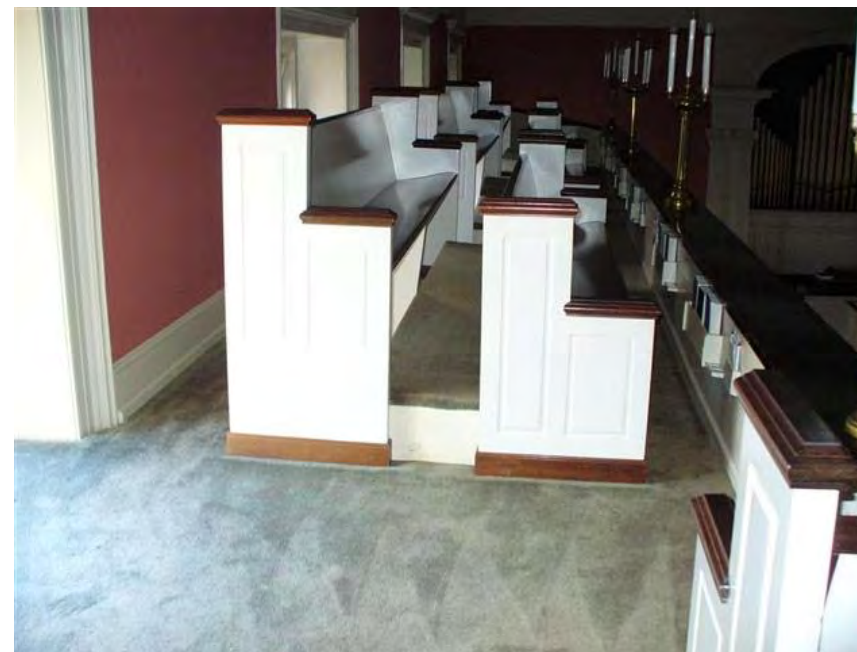
The pews located in the balcony give the illusion that the balcony floor is sloped. The rear pew is elongated in height, with a carpeted riser platform to access the raised seating.

Typical balcony pews. Carpeted riser platform is not attached to the pew.

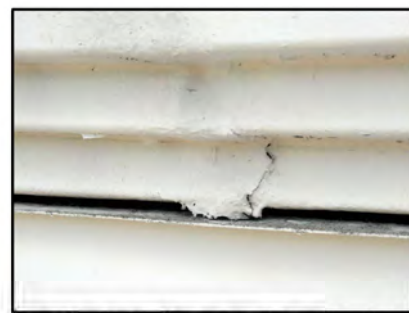
Cornice and frieze- not weathertight

Recommendations: The fiberglass bell tower is generally in good condition, particularly as observed from the exterior. There are several connection details which may allow water penetration - however they are not changeable at this point in time. As long as the belfry floor and roof is water tight against the attic those connections need not be of concern. The interior material surface does appear to be disintegrating to some degree. It will take a fiberglass expert to determine the remaining lifetime of the fiberglass tower. The steel substructure is well designed, durable and well connected to the main structure of the Sanctuary. As stated earlier, the framing of the belfry floor, the wood support for this framing and the wood structural members holding the perimeter of the tower base are compromised on all four corners and need to be repaired and, in some cases, replaced. New roofing, preferably using coated copper or stainless steel needs to be installed in conjunction with the recommended flashing

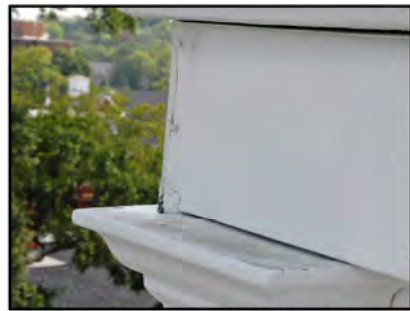
Capital detail- not weathertight

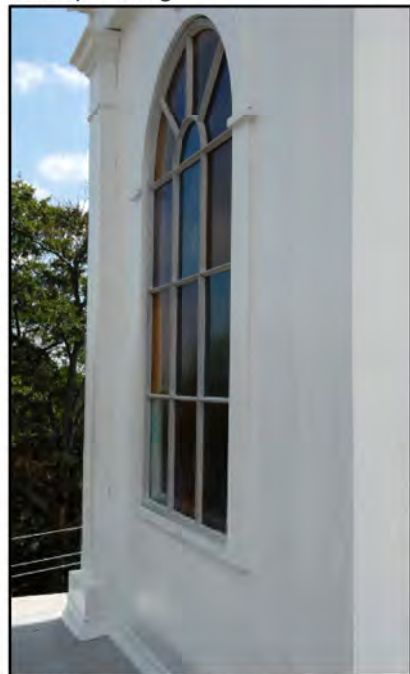
Belfry window: The colored glass windows at the tower belfry are located on the North and South elevations. The glass panes are pink, gold, and blue. The frame and mullions are in fair condition, some of the putty is cracking and will need to be replaced.

Colored glass window at North and South elevations

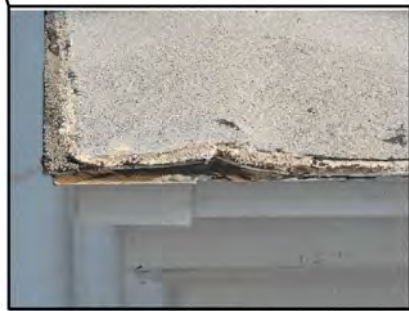
Edge of built-up roofing

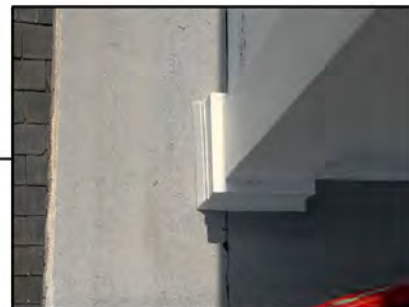
Built-up roofing and base

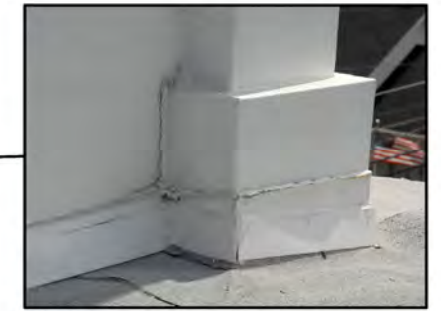
Flashing at corner base

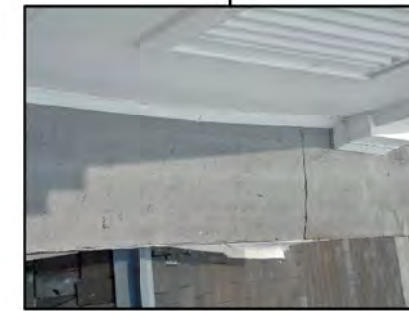
Fiberglass skirt and built-up roofing

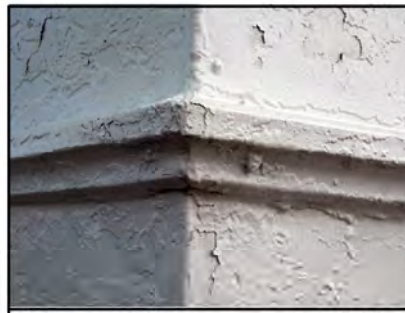
Historic paint layers on only joint in metal tower base wall

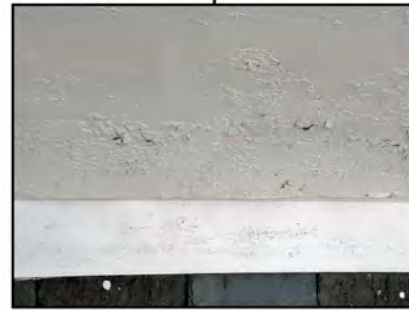
Skirt flashing at North side of tower base

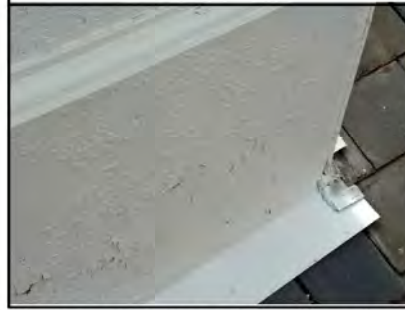
Flashing at slate roof (Northwest corner)

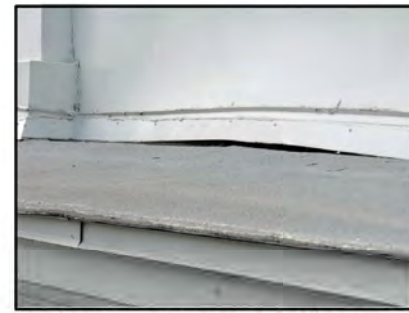
East side flashing gap, built-up roofing

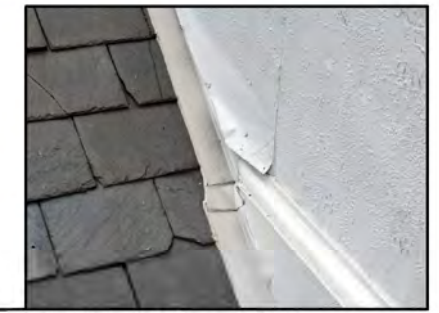
Flashing detail- metal skin not weathertight

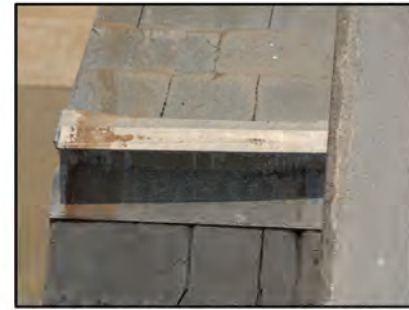
Corroded gable cap on slate roof exterior of gable wall

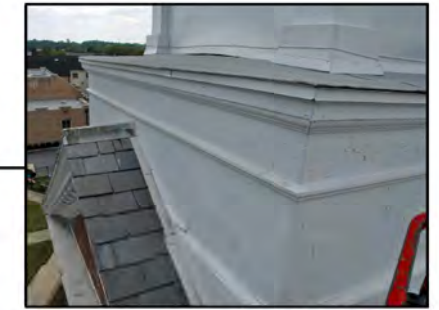
East side, slate roof eave and tower base flashing

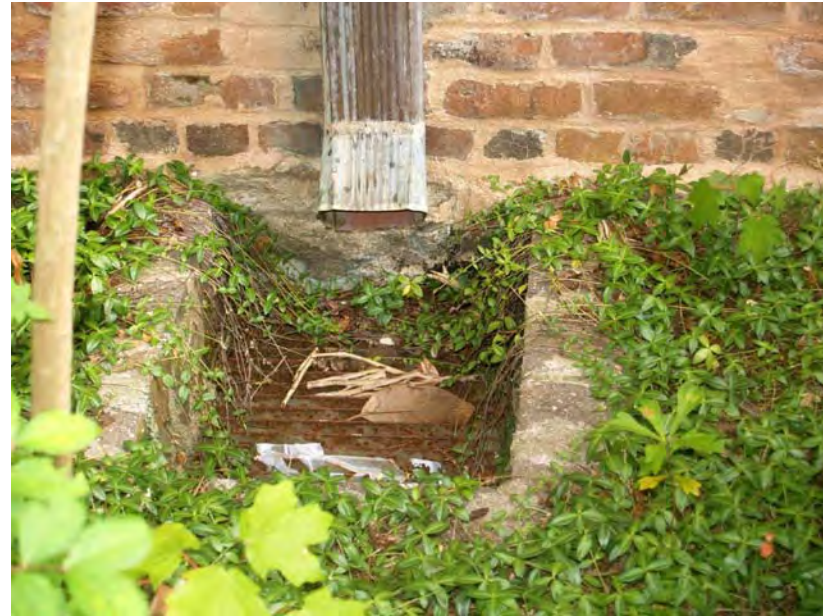
1- Roof Drain Discharge at Grate

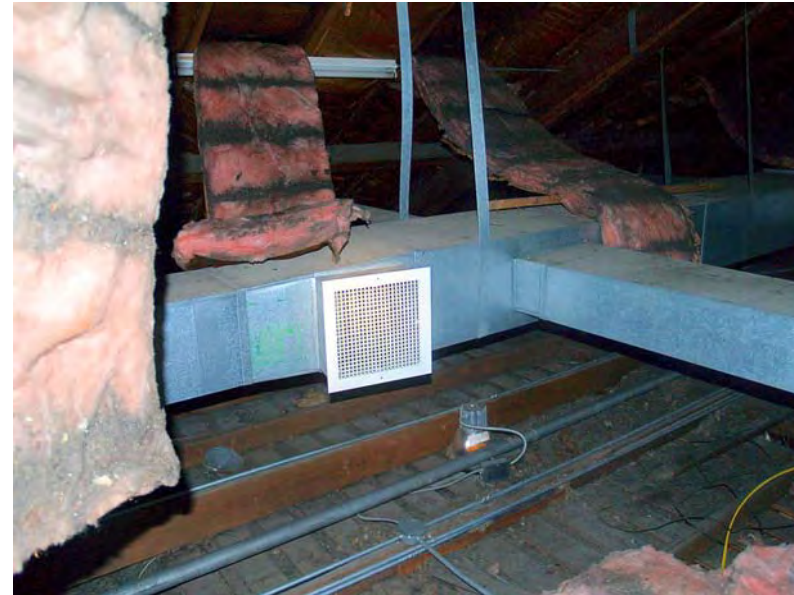
There are two eggcrate type grilles supplying a small amount (300 CFM total) of conditioned air into the attic. We assume the intent is to reduce humidity in the attic. However, the small air quantity will provide limited reduction of humidity in the attic. Roof insulation is

3- Supply Grille Discharging Into Attic

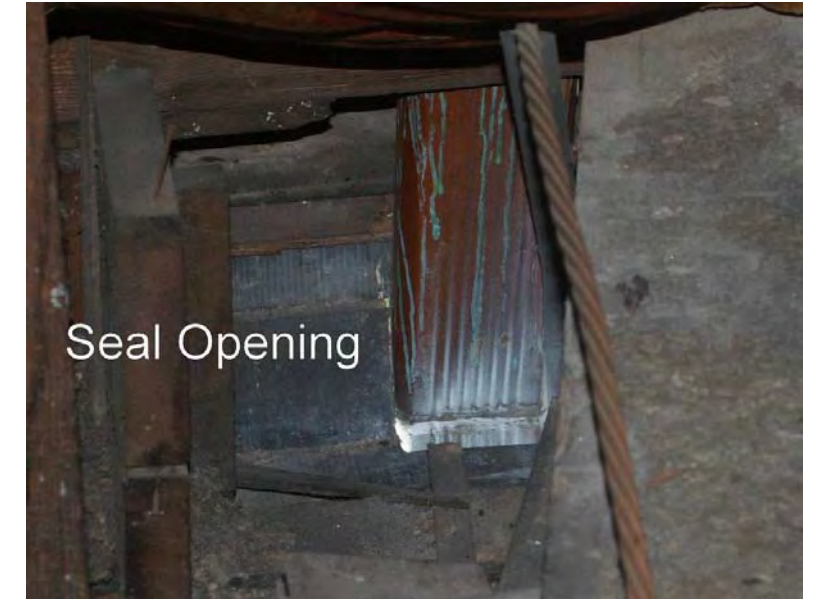
5- Seal Opening Between Downspout and Metal Fascia

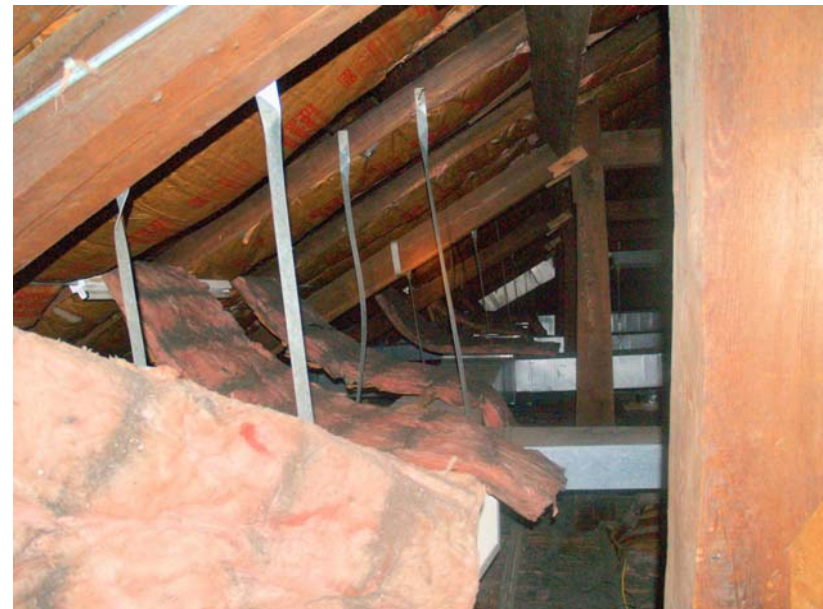
2- Fallen Roof Insulation in Attic

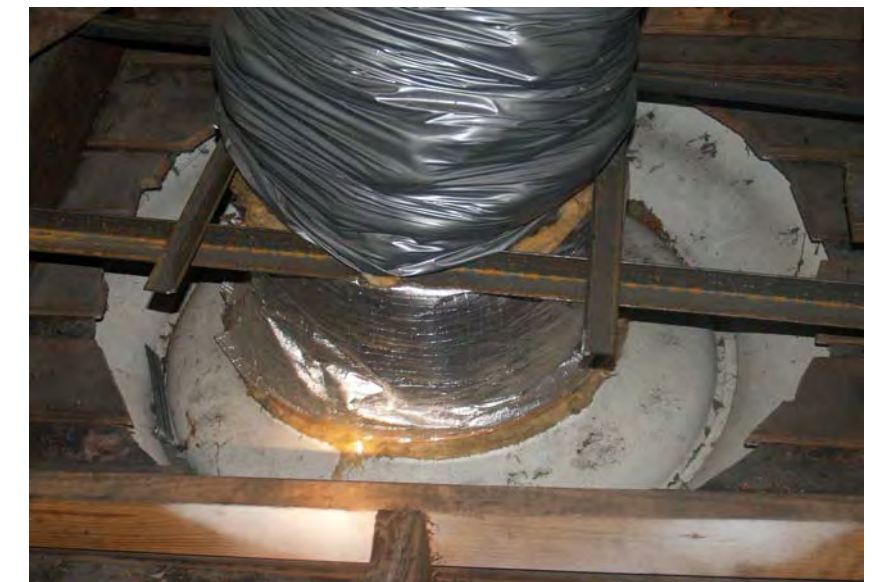
6 Un-Insulated Diffuser back in Attic-Needs to be Insulated

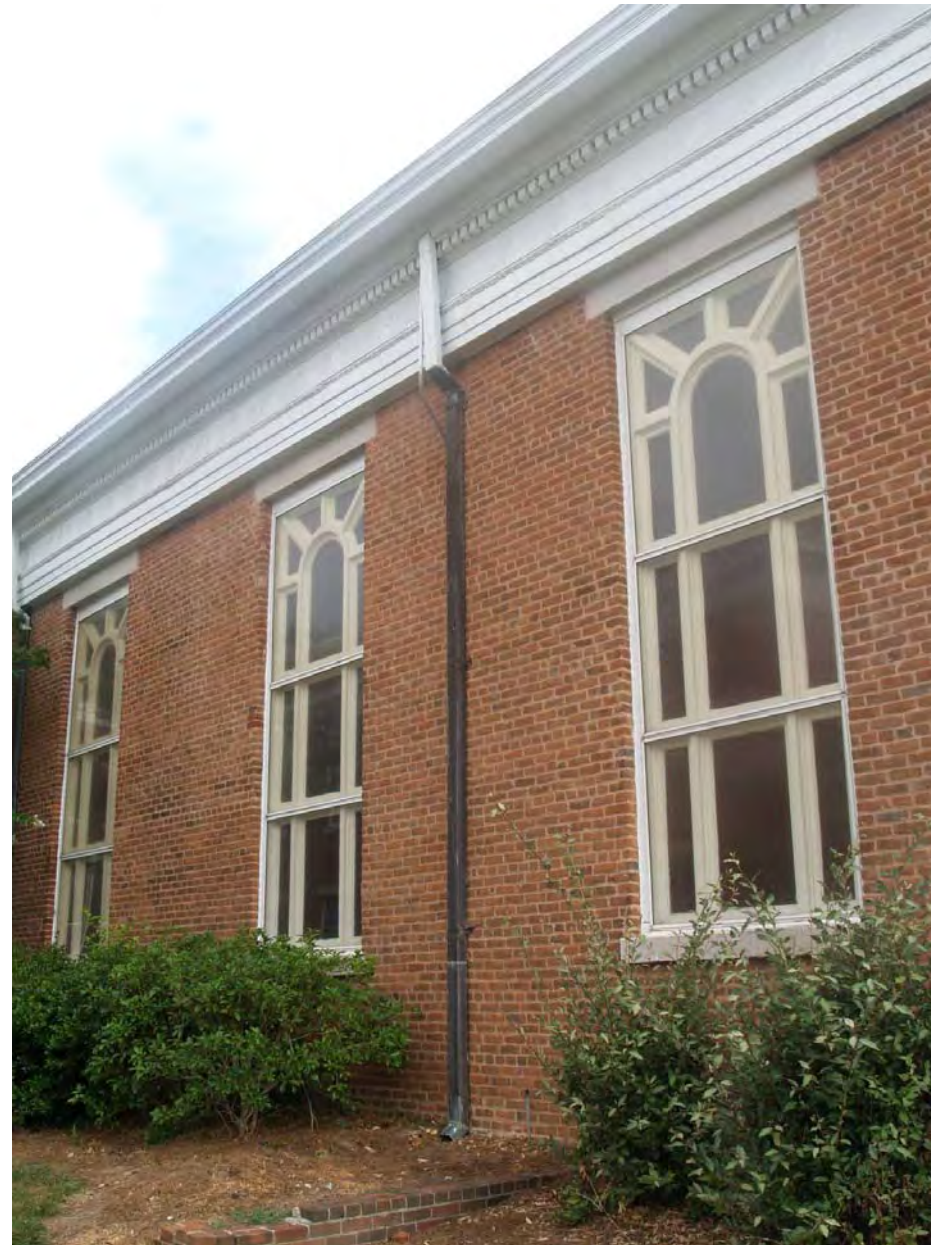
17 Rain Downspout – All Appear To Be In Good Condition

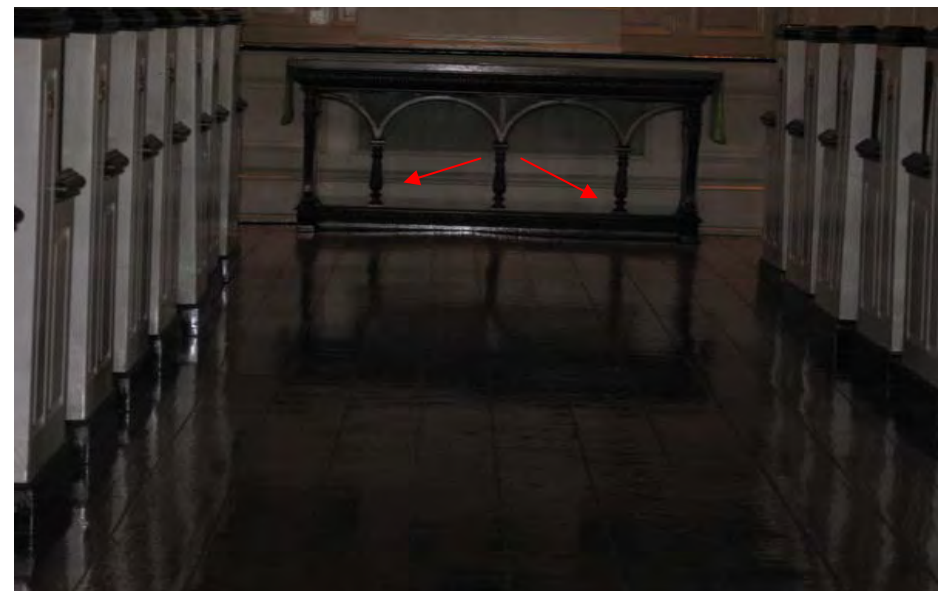
1. In the Sanctuary, the floor appears to be depressed in some areas. This is particularly visible along to the left and right sides (from the central axis of the room) and at some balcony post bases. (See Photos 1 and 2).

Photo 2 – Slab depression at sanctuary floor

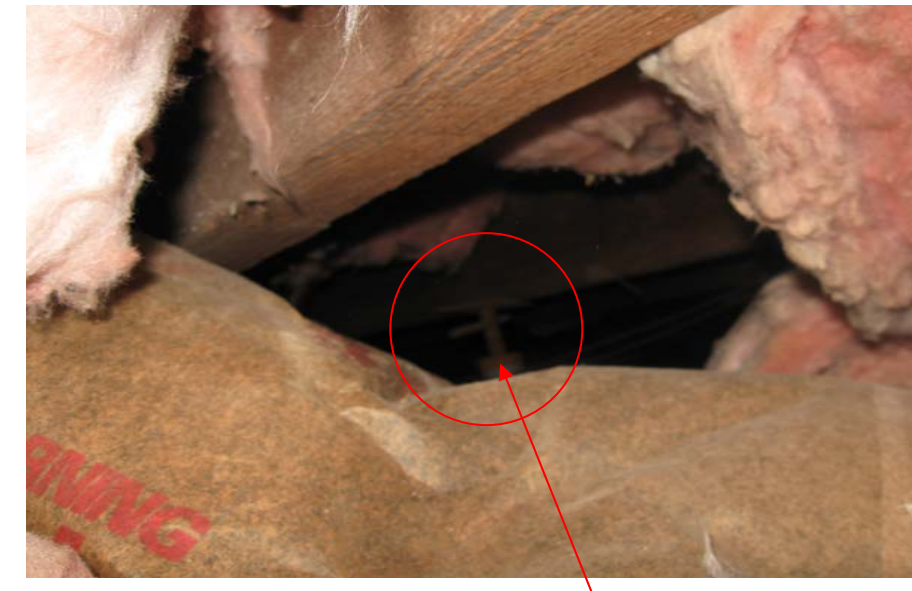
The sanctuary floor framing consists of 3"x12" floor joist spaced at 24" on center supported by a continuous granite foundation along the central axis of the room and masonry walls at the building perimeter. At the mid span of each floor joist, additional support consisting of 3" diameter adjustable steel posts has been added at various locations sometime in the past, to provide additional supports. (See Photo 4)

Photo 4 – Adjustable steel post for floor joist support

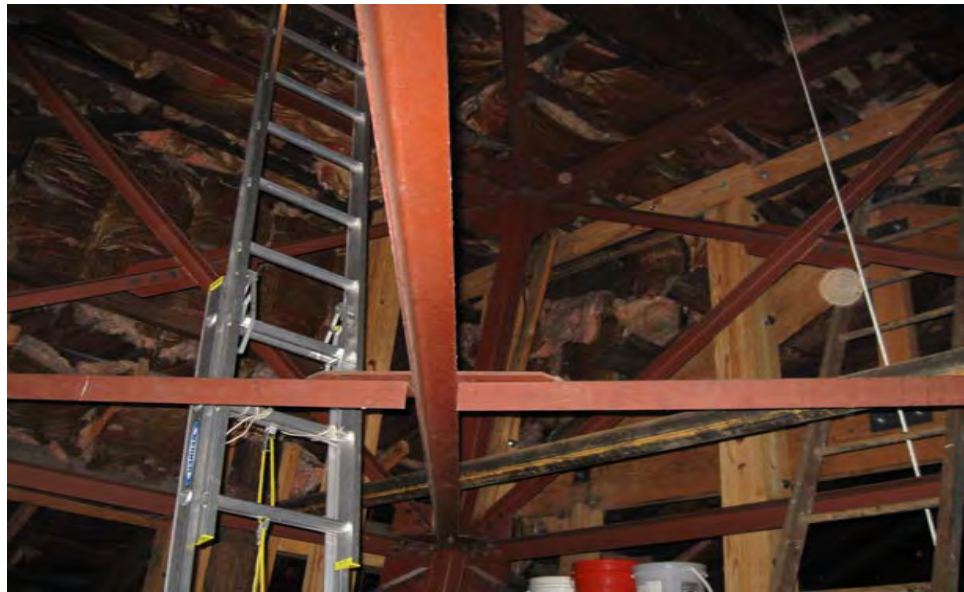
2. As mentioned previously, the steeple is not part of the original construction of the building and has been replaced at least twice in the past. The actual steeple frame consists of lower steel "X" braced frames in the attic space located over the Narthex and upper steel "X" braced frames welded to the lower frames with steel tubes thru the bell tower wood floor. This upper frame is enclosed by a wall system consisting of wood and steel members covered in fiberglass and extending to the peak of the steeple. (See Photos 5, 6 and 7)

The lower braced framed system of the steeple (See Photos 5 and 9) is supported on two 12" wide steel flange beams anchored to 24"x17" concrete grade beams poured over the original masonry walls along the perimeter of the lower narthex area. The steel beams are connected to four ¾-inch diameter tie rods (one at each end of the beam) and tensioned with the help of turnbuckles (See Photo 8). Each tie rod extends to the ground floor. The fastening to the foundation system was not visible.

Photo 5 – Lower steeple support frame

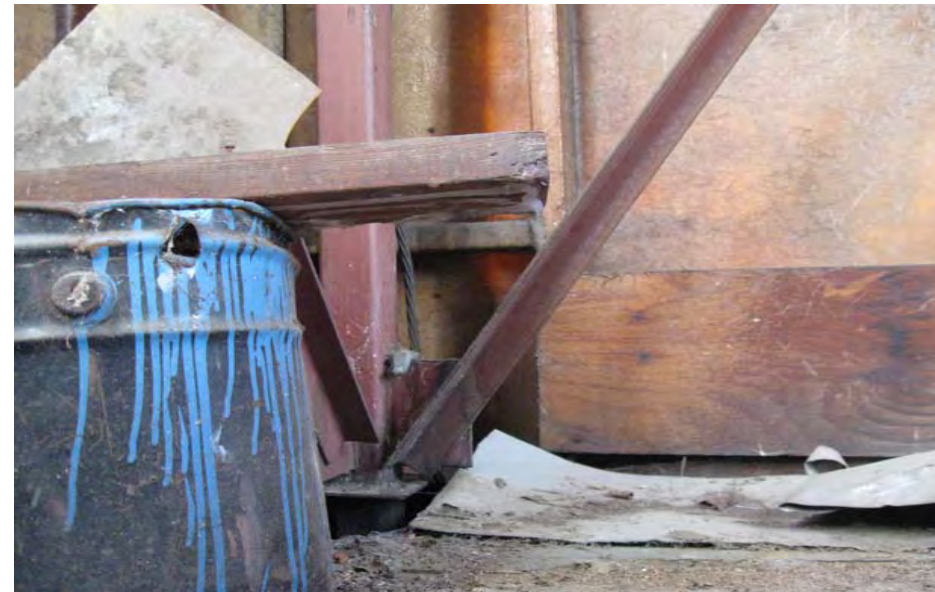
Photo 7 – Transition between lower and upper steel frames
