First Presbyterian Church of Marietta

Preservation Plan and Assessment of the Historic Sanctuary Structure

Lord Aeck Sargent Architecture, Inc.

October 24, 2008

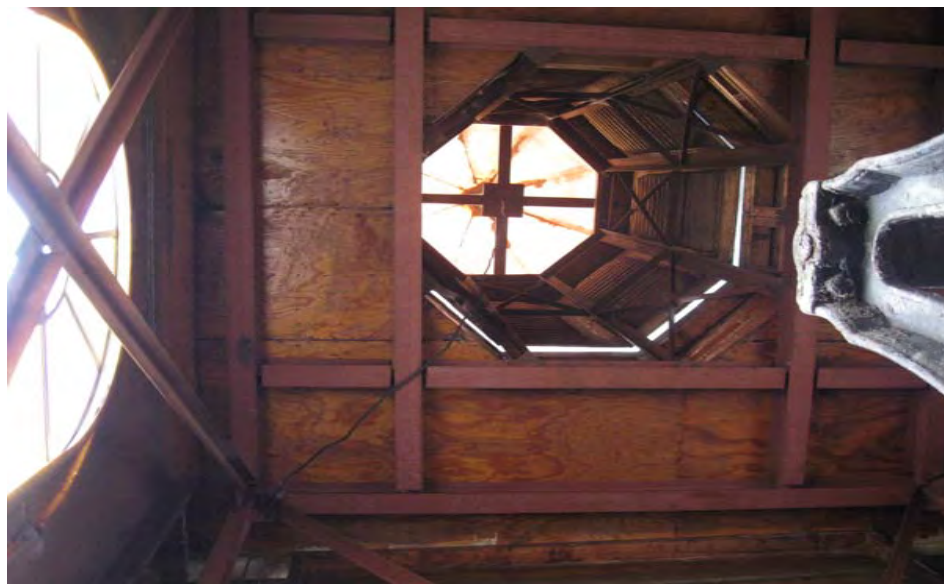
2. As mentioned previously, the steeple is not part of the original construction of the building and has been replaced at least twice in the past. The actual steeple frame consists of lower steel "X" braced frames in the attic space located over the Narthex and upper steel "X" braced frames welded to the lower frames with steel tubes thru the bell tower wood floor. This upper frame is enclosed by a wall system consisting of wood and steel members covered in fiberglass and extending to the peak of the steeple. (See Photos 5, 6 and 7)

Photo 6 – Upper steeple support frame

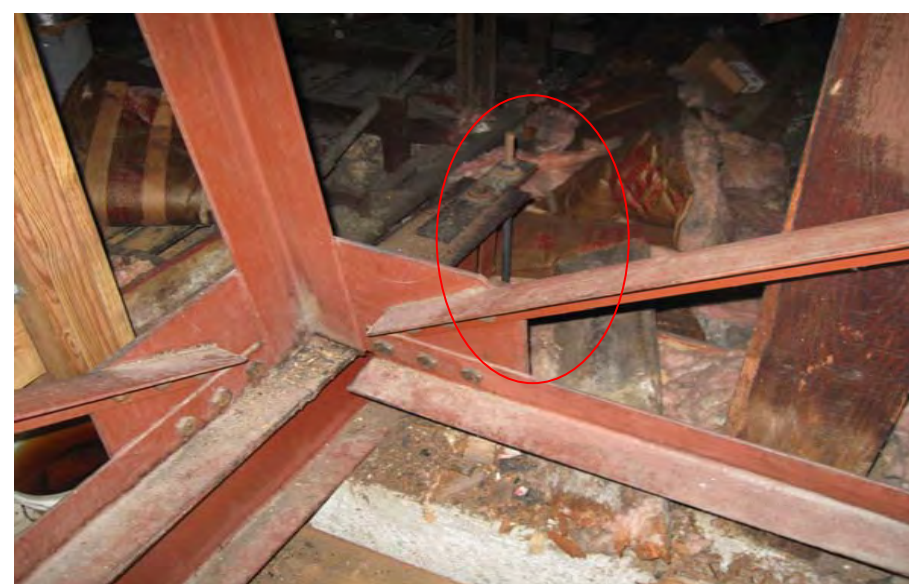
The lower braced framed system of the steeple (See Photos 5 and 9) is supported on two 12" wide steel flange beams anchored to 24"x17" concrete grade beams poured over the original masonry walls along the perimeter of the lower narthex area. The steel beams are connected to four ¾-inch diameter tie rods (one at each end of the beam) and tensioned with the help of turnbuckles (See Photo 8). Each tie rod extends to the ground floor. The fastening to the foundation system was not visible.

Photo 8 – Tie rod at end of steel beam

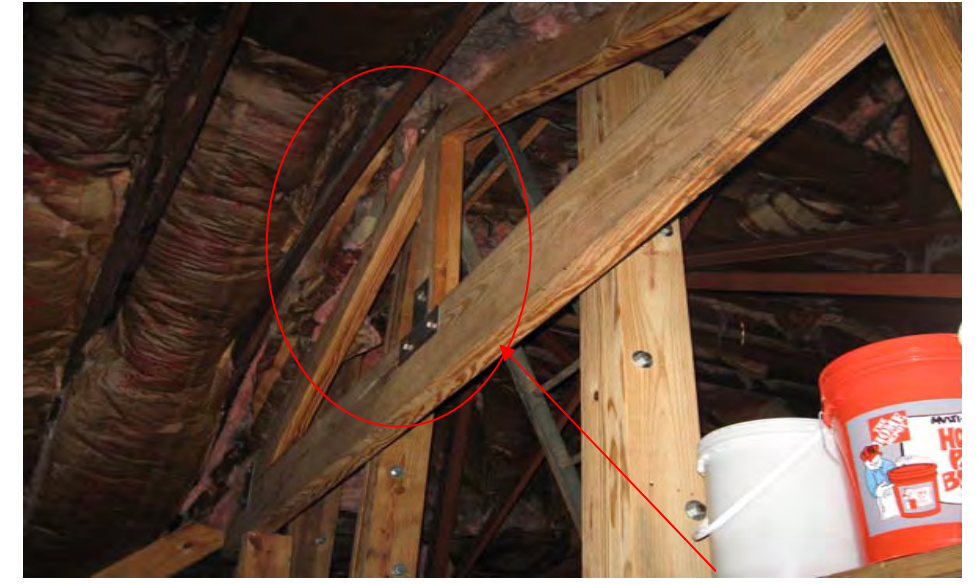
The installation of the present steeple required the removal of previous wood roof framing members which initially supported part of the original steeple and the sanctuary roof. This is evident by the addition of a new truss which provides the existing roof support and new post and beams for the steeple floor and lower roof support. (See Photos 5, 9 and 10).

Photo 10 – Additional wood framing members for roof support

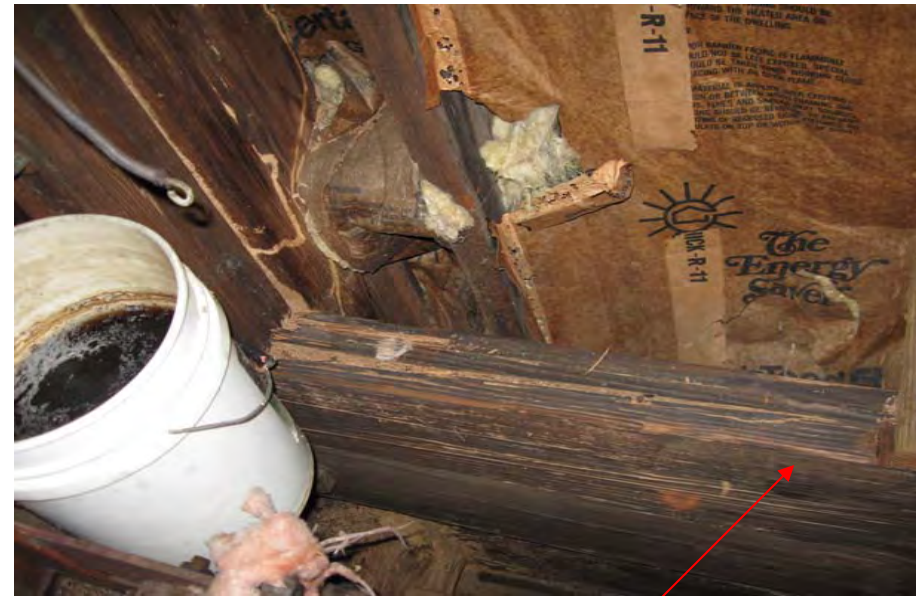
4. The original structural framing of the gable end wall over the entrance of the church (visible from the base floor of the steeple) appeared to have been modified at some point to include a window and brick fascia (See Photos 13 and 14). The wood framing elements were partially concealed by insulation. We did manage to examine part of the wall framing. It consisted of heavy timber post (aligned with the sanctuary roof truss system) with 2x4 wood vertical studs infill and wood bracing nail to its exterior face. Some of the original wood members appeared to have been damaged by water infiltration and subsequently reinforced with new bolted wood elements possibly when the work for the latest replacement of steeple was done. The reinforcement appeared adequate and there were no visible major structural anomalies to the wall. However, in one location, we did observe light filtering thru the wall. We recommend that the gable end wall be reviewed by a qualified envelope specialist to determine its condition.

Photo 13 - Gable End Wall Framing (Base of Wall)
