First Presbyterian Church of Marietta

Preservation Plan and Assessment of the Historic Sanctuary Structure

Lord Aeck Sargent Architecture, Inc.

October 24, 2008

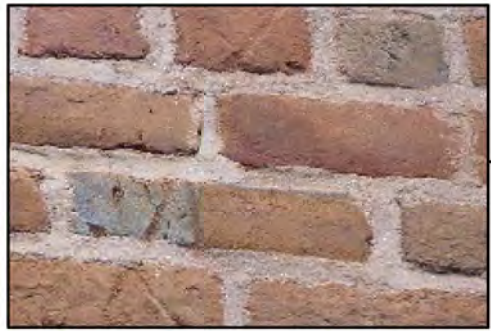
Scratched/ scored masonry

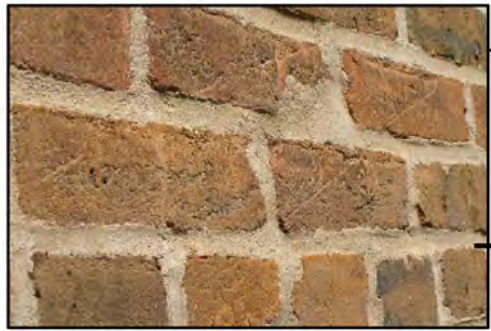
Scratched/ scored masonry

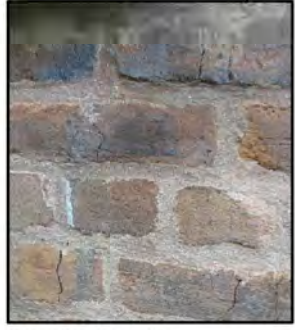
Cracked bricks

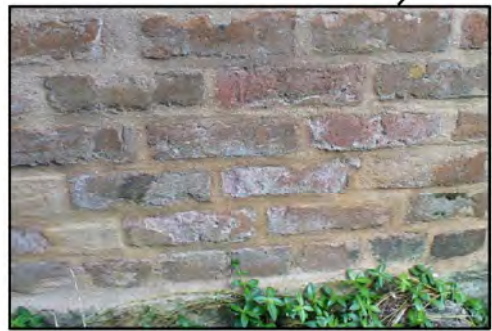
Efflorescence

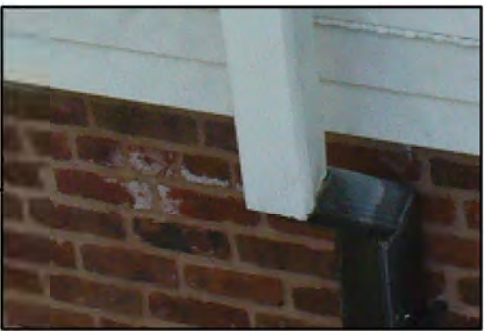
Efflorescence

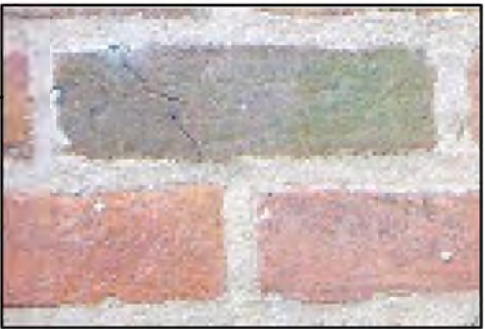
Cracked brick

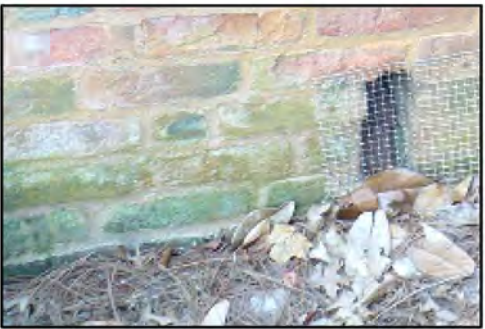
Biological growth

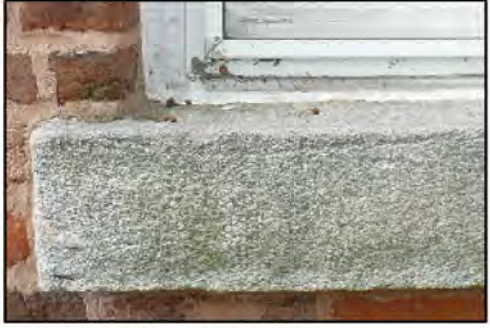
Sandblasted granite

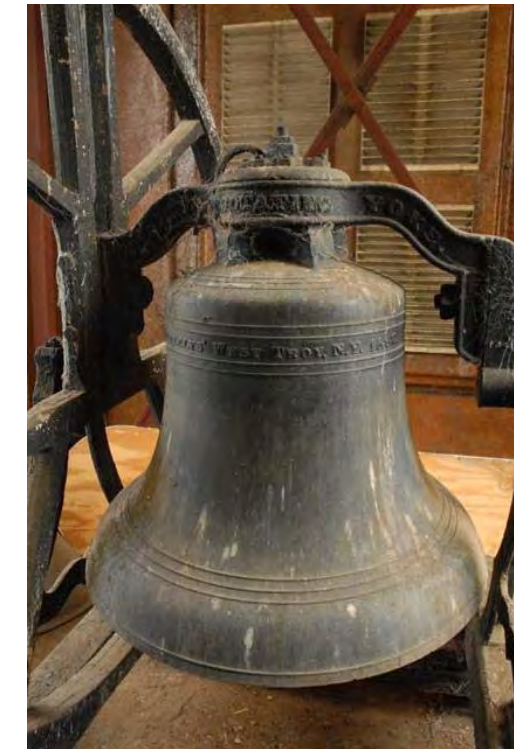
Church bell: The church bell inside the belfry and its carrier structure is cast iron, in good condition.

Cast iron bell in belfry

Recommendation: Cleaning and corrosion protection

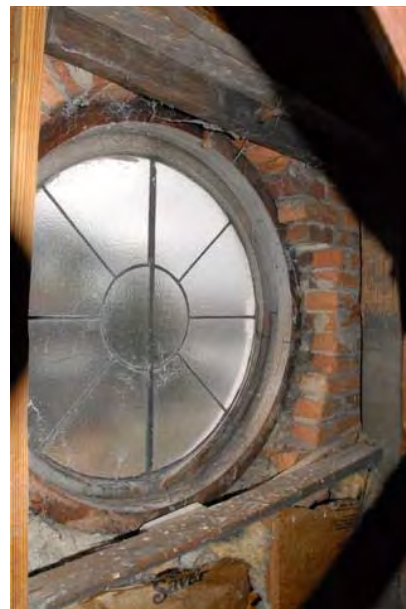
East Gable Round Window

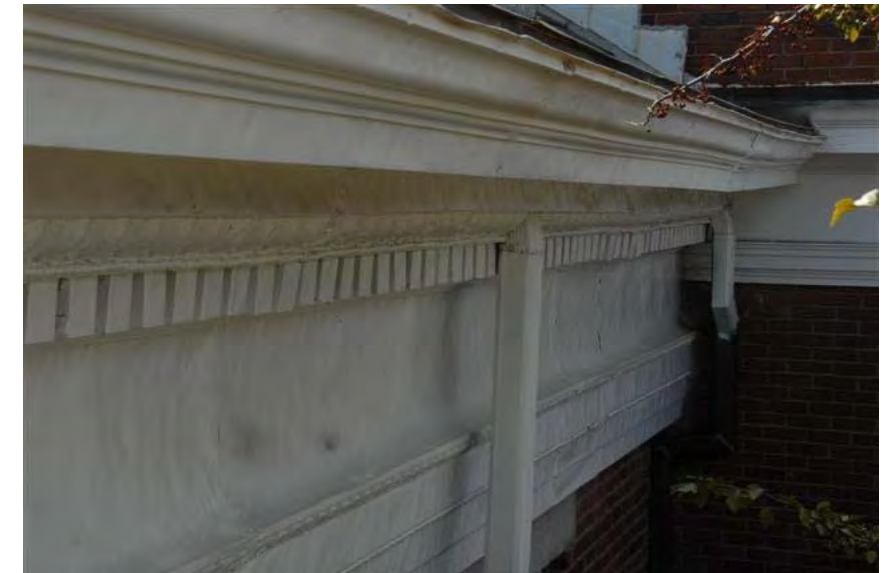
The overall gutter assembly along the north side of the church is somewhat curved in the bay over the second window bay from the back (west). There is an additional overflow protection at the last bay of the gutter, starting at the shared new exterior wall of the Holland Hall building. However, in general, the gutters are functioning well and holding up without any major defects.

Gutter and entablature on North side

Recommendations: Observe flow pattern at roof edge and in the gutters during a strong rainfall. Make adjustments and drainage corrections to improve the controlled water flow.

Correct bent and damaged leader pipes - limited occurrences. Replace wall attachment brackets where damaged and remove all fasteners into masonry with stainless steel fasteners and non-pressure anchors.

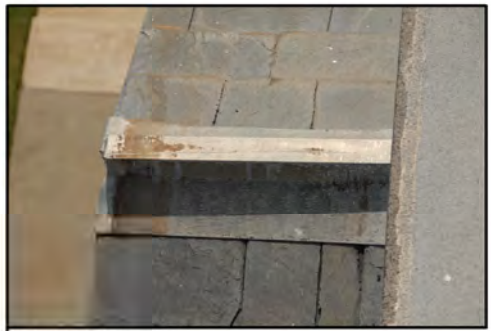
Galvanized steel ridge cap

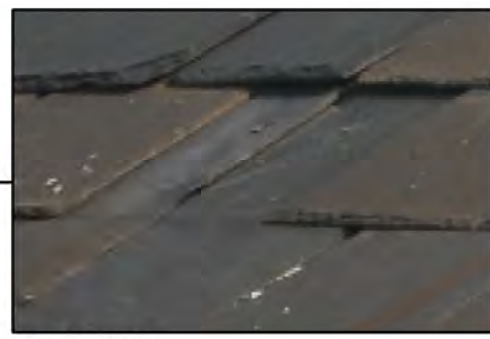
Missing slate tile

Recommendations: Replace all tiles which have slipped and fell off the roof. Possibly replace the black repair tiles, particularly in areas where they are the only tile in a surrounding of original grey slate tiles.

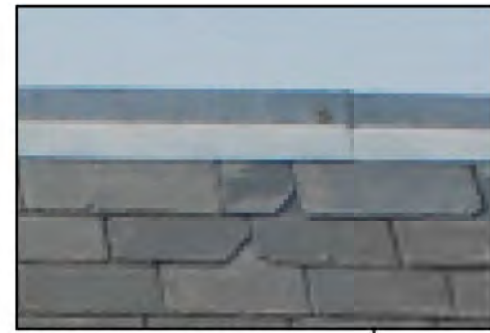
Chipped slate edges near galvanized steel ridge cap

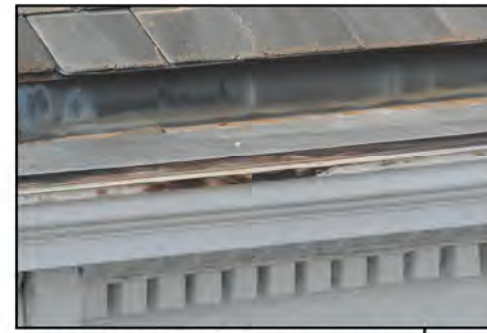
Rusting connection between original entablature and new gutter

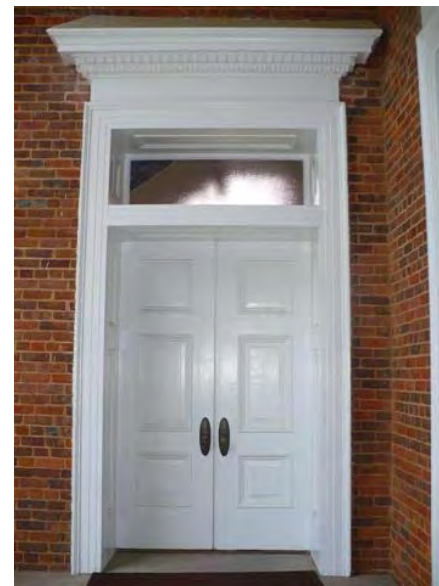
Door 101 Exterior

At the east entrance, all the exterior doors have transoms with translucent textured glazing. All doors to the exterior maintain historic door knobs, hinges, and latch bolts at the floor and header. A modern brass deadbolt is presently used to secure each exterior door. All three doors lack panic push bar hardware and both side doors (#101 and #102) open to the interior, in non-compliance with accessibility codes.

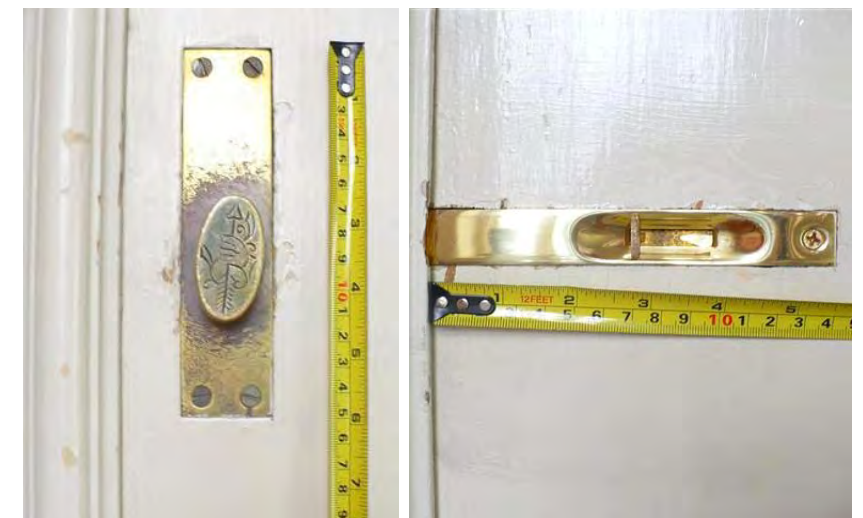
Door 101 historic latch bolt

Door 101 modern dead bolt

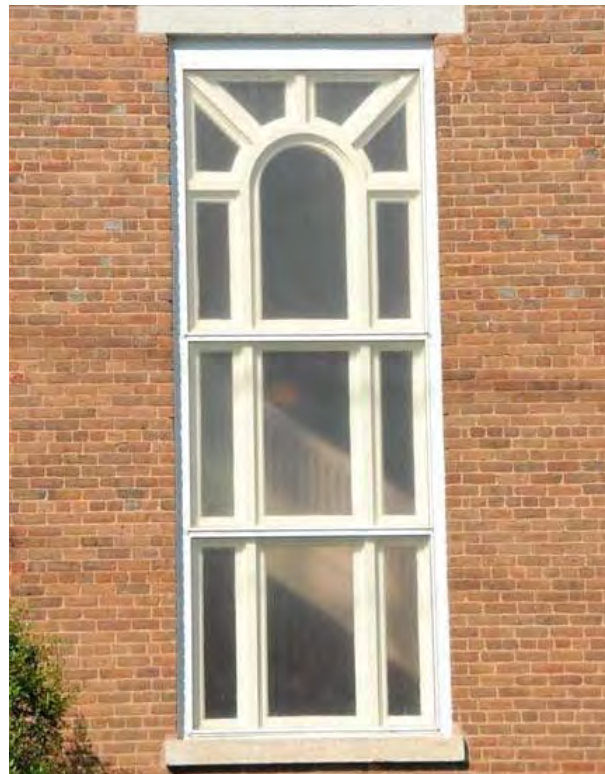
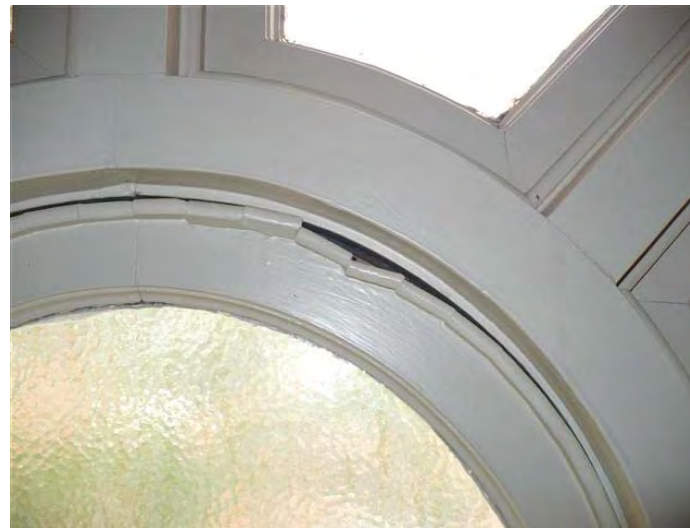
The sanctuary and the two vestibules feature 12 cathedral glazed windows. These new windows replaced the original 1854 triple hung wood sash windows within the same opening. The 1905 windows consist of a bold, triple central bay with an arched top section, flanked by three narrow window panes on each side with a group of four small panes on top, divided by a 45 degree muntin from the top arch into the upper corner of the window. All regular, major window units were operable awning windows to allow for full direct ventilation to the outside. After the installation of permanent exterior plexi-glass storm windows (pre 1979), the opportunities to open the awning windows had been eliminated. This has been further reinforced by having painted over all separating joints of all windows i.e. they are currently painted and caulked shut. The caulking seal shows signs of deterioration in some select areas.

Recommendation: Besides a few paint corrections and possibly a glass replacement to match the original there are no major issues with the windows, besides routine maintenance. Window header at # 4 needs to be reattached to wall.

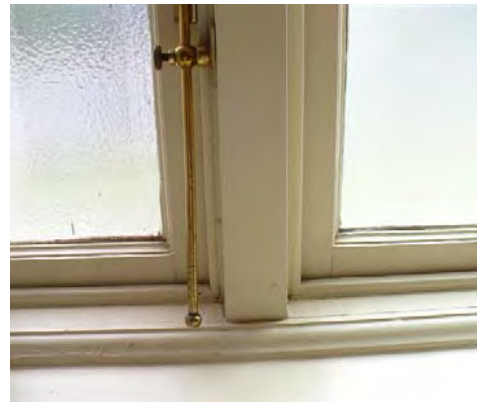
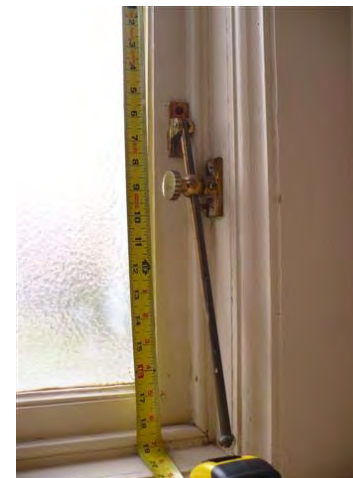
Generally, the inoperable brass awning hardware is in good condition. However, one set of awning hardware is missing at windows 2 and 11. At windows 2-4 and 9-11, the awning hardware has been installed above its original location to avoid conflict with the height of the balcony floor. Replacement textured glass panes are evident at windows 1, 2, and 6.

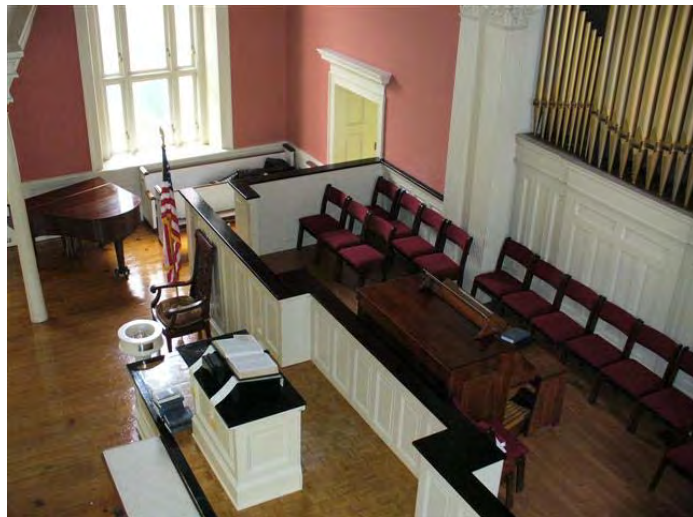
The flooring at the choir loft is a modern wood imitation "hardwood" floor in good condition. The flooring at the pulpit is a 4"x 4" parquet style wood tile framed by a 4" black painted wood edge trim, also in good condition.

Flooring at pulpit and choir loft

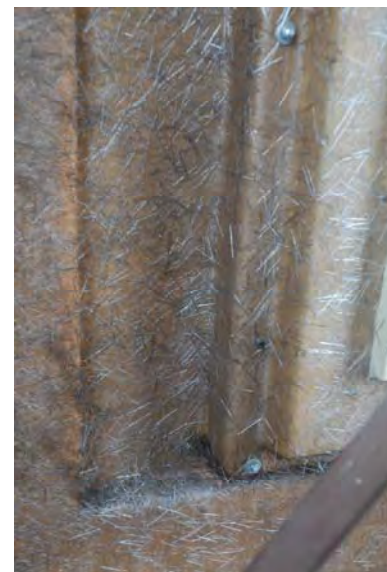
The inner steel structure of the belfry and the steeple - dating from 1969/72 when the new fiber glass tower was installed - is holding up rather well. It does have a good amount of structural resistance. The outer surface is spotless and holds up extremely well. The fiberglass surface on the inside of the tower structure shows more signs of distress and aging.

Recommendations: The fiberglass bell tower is generally in good condition, particularly as observed from the exterior. There are several connection details which may allow water penetration - however they are not changeable at this point in time. As long as the belfry floor and roof is water tight against the attic those connections need not be of concern. The interior material surface does appear to be disintegrating to some degree. It will take a fiberglass expert to determine the remaining lifetime of the fiberglass tower. The steel substructure is well designed, durable and well connected to the main structure of the Sanctuary. As stated earlier, the framing of the belfry floor, the wood support for this framing and the wood structural members holding the perimeter of the tower base are compromised on all four corners and need to be repaired and, in some cases, replaced. New roofing, preferably using coated copper or stainless steel needs to be installed in conjunction with the recommended flashing

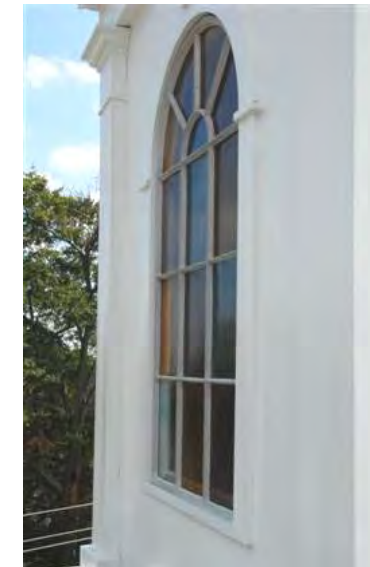
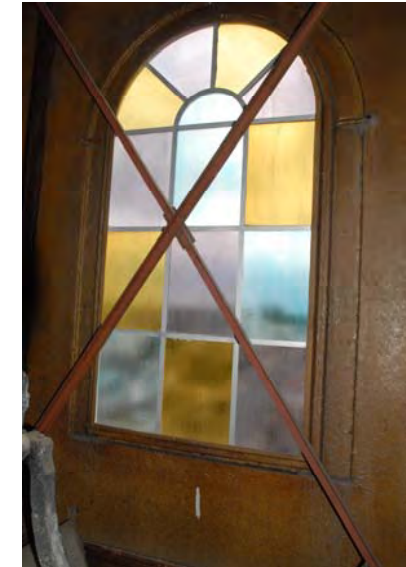
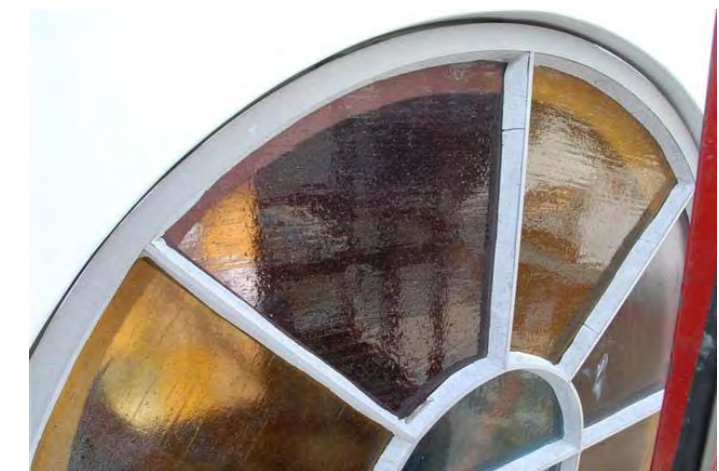
Belfry window: The colored glass windows at the tower belfry are located on the North and South elevations. The glass panes are pink, gold, and blue. The frame and mullions are in fair condition, some of the putty is cracking and will need to be replaced.

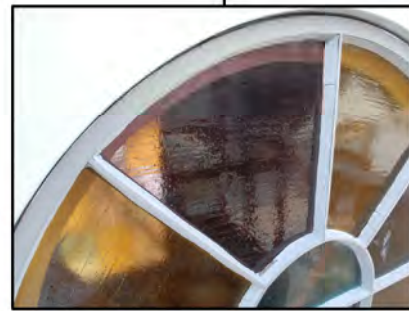
Window detail

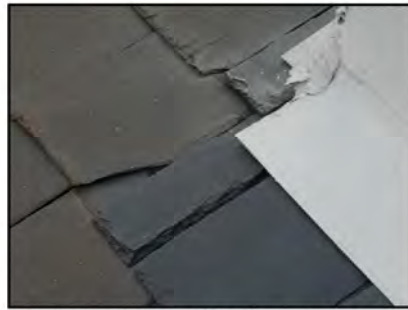
Flashing detail at Northeast corner

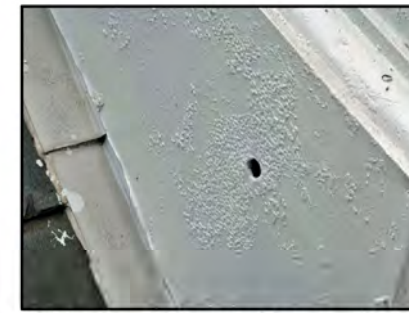
Original metal base of tower with hole

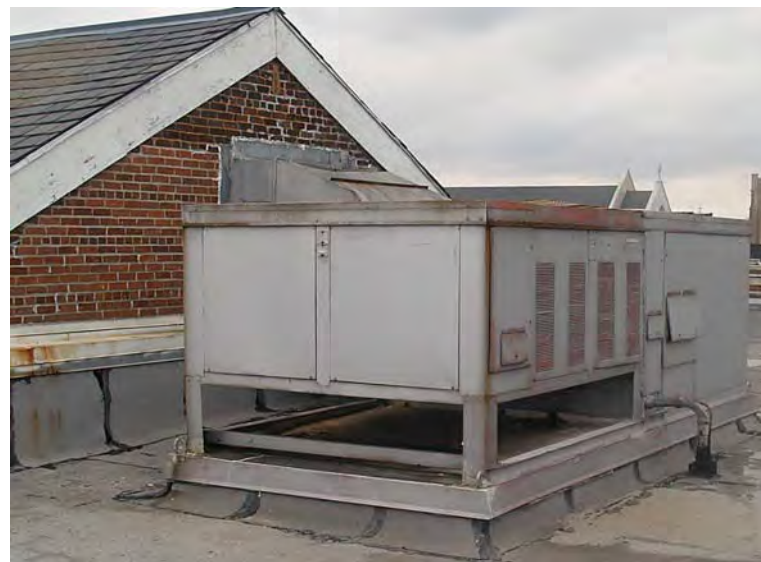
10 Rooftop Unit

Replacement of the rooftop cooling unit should be planned due the age of the unit. The Chrysler Corporation no longer makes HVAC equipment, thus generic parts would need to be used if failures occur. At this time, the unit appears to be in serviceable condition. Coils did not appear to have deterioration that would be expected for a unit of this age.

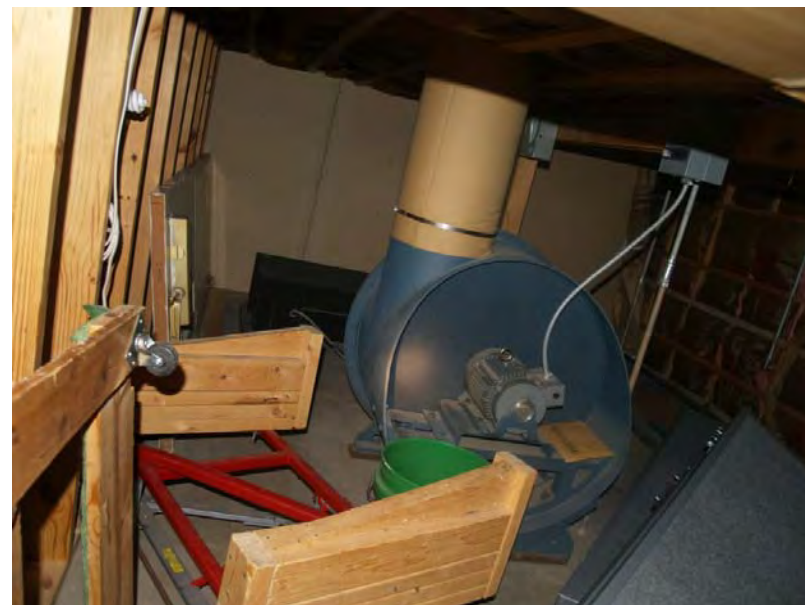
Organ Blower – Good Condition

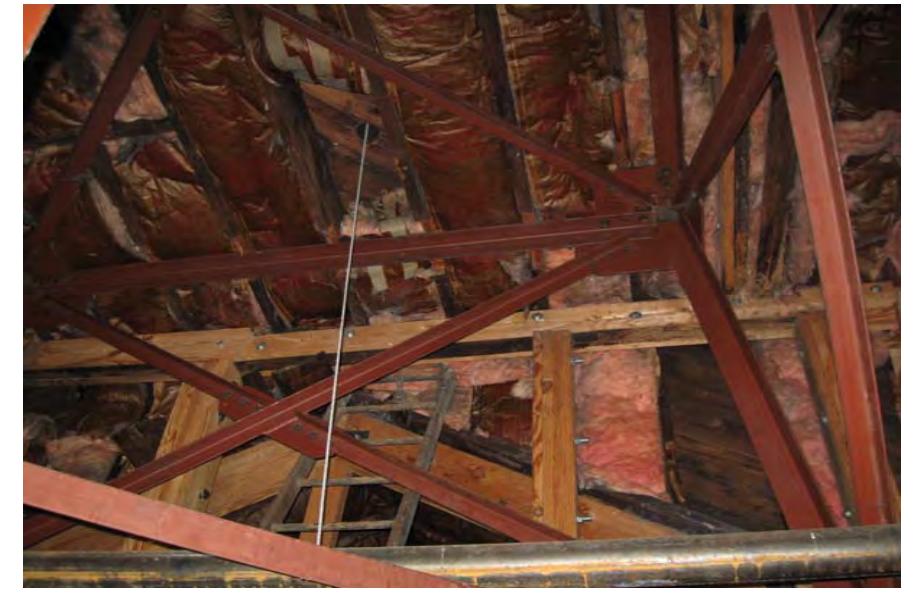
The installation of the present steeple required the removal of previous wood roof framing members which initially supported part of the original steeple and the sanctuary roof. This is evident by the addition of a new truss which provides the existing roof support and new post and beams for the steeple floor and lower roof support. (See Photos 5, 9 and 10).

Photo 9 – Additional wood framing members for floor support

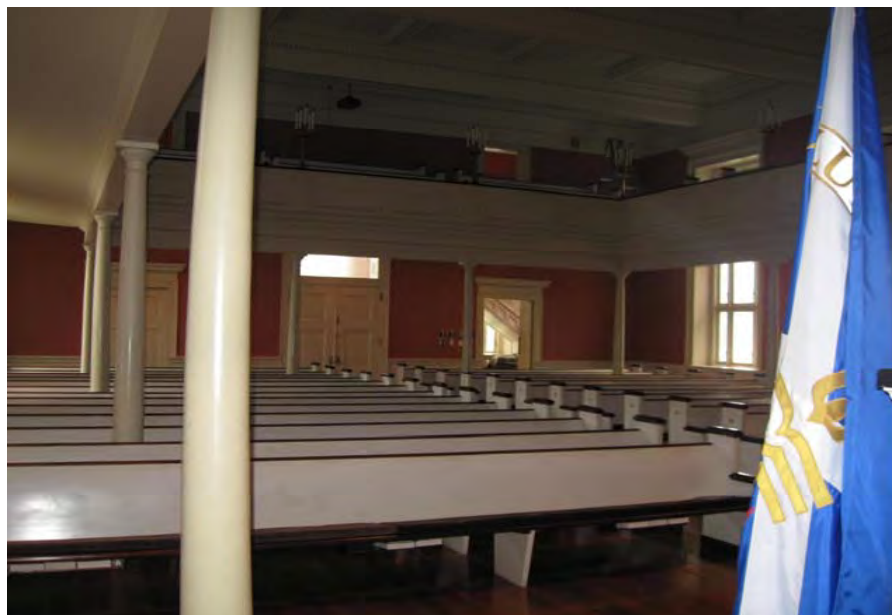
One wood post supporting the balcony located to the right of the pulpit is bowed at the upper tier of the post. We believe that this condition is not recent and is structurally stable.

Photo 12 – Bowed Post

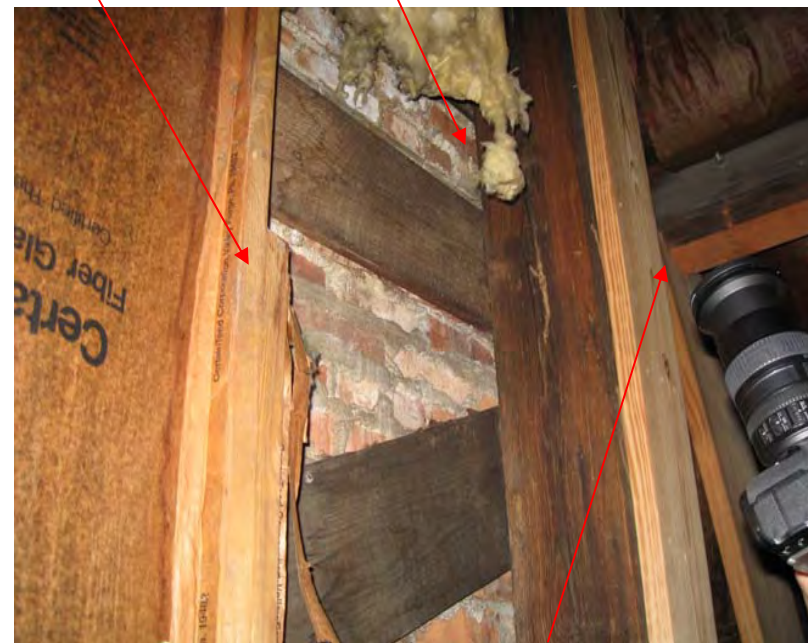
4. The original structural framing of the gable end wall over the entrance of the church (visible from the base floor of the steeple) appeared to have been modified at some point to include a window and brick fascia (See Photos 13 and 14). The wood framing elements were partially concealed by insulation. We did manage to examine part of the wall framing. It consisted of heavy timber post (aligned with the sanctuary roof truss system) with 2x4 wood vertical studs infill and wood bracing nail to its exterior face. Some of the original wood members appeared to have been damaged by water infiltration and subsequently reinforced with new bolted wood elements possibly when the work for the latest replacement of steeple was done. The reinforcement appeared adequate and there were no visible major structural anomalies to the wall. However, in one location, we did observe light filtering thru the wall. We recommend that the gable end wall be reviewed by a qualified envelope specialist to determine its condition.

Photo 14 - Gable End Wall Framing (Reinforcement)
